**GLOBAL ALLIANCE FOR VACCINES AND IMMUNIZATION (GAVI)
HEALTH SYSTEM STRENGTHENING II (HSS-2) PROGRAMME**

***PRILIMINARY ASSESSMENT REPORT
EPI BUILDING, BAGERHAT***

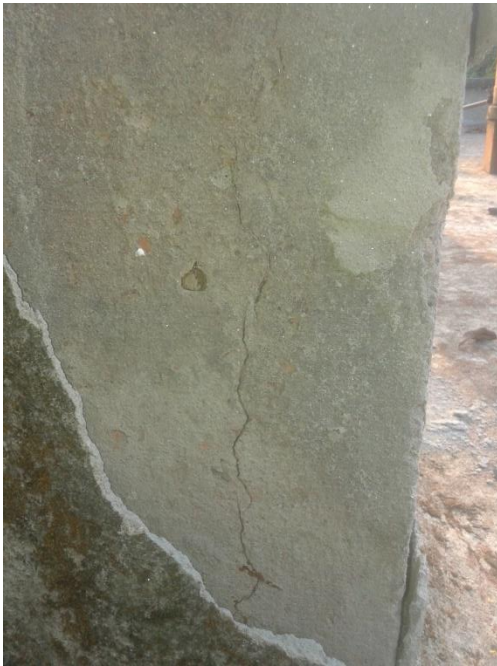
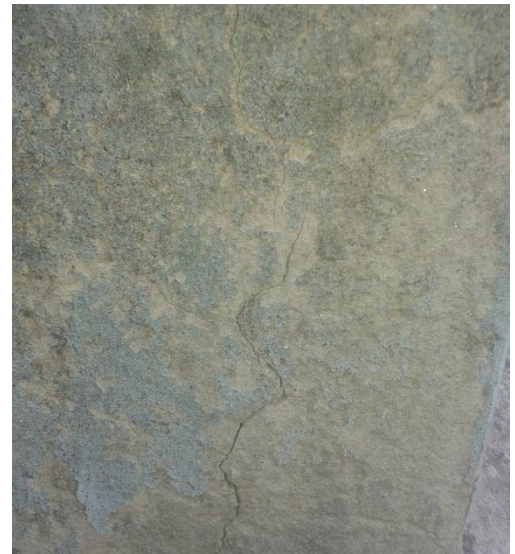
Figure 6.1: Crack in Column

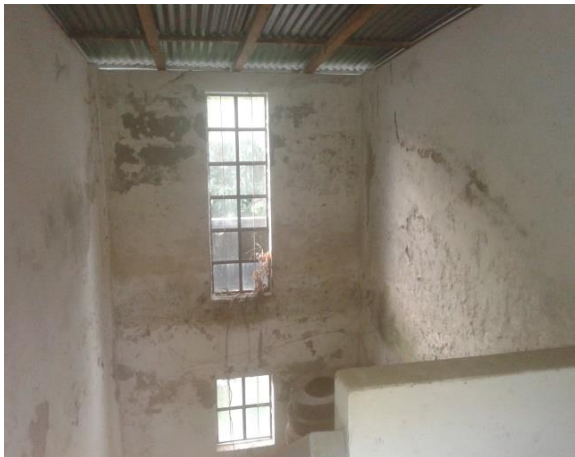
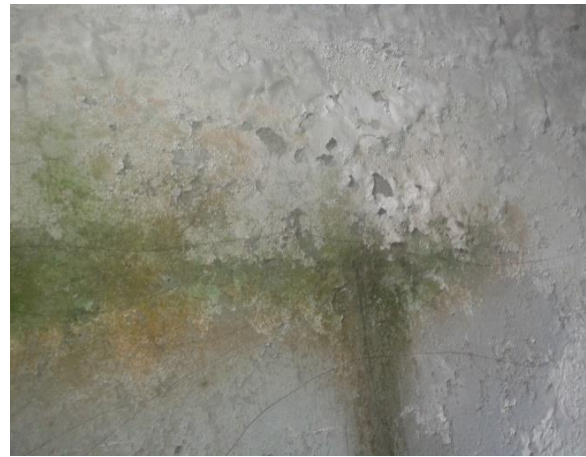
Figure 6.2: Dampness on the wall

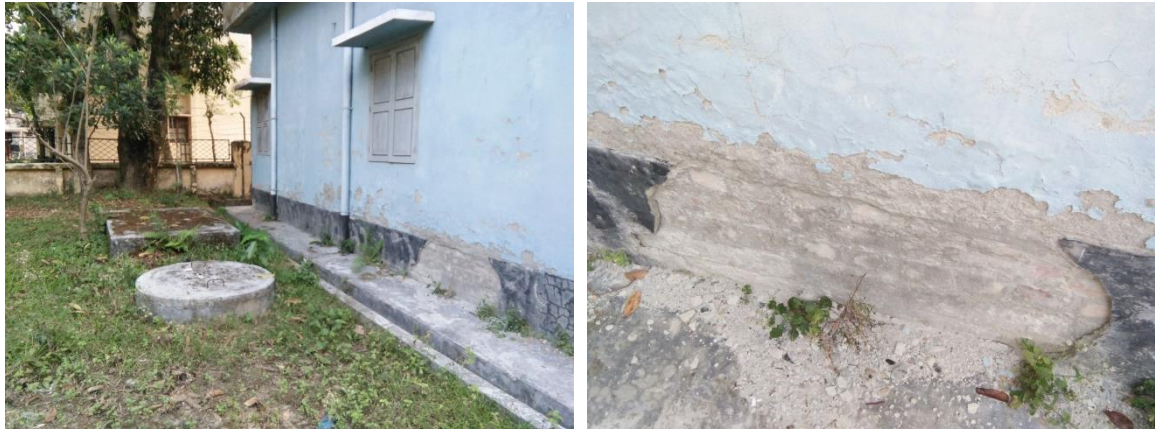
Figure 6.3: Damaged outside plaster

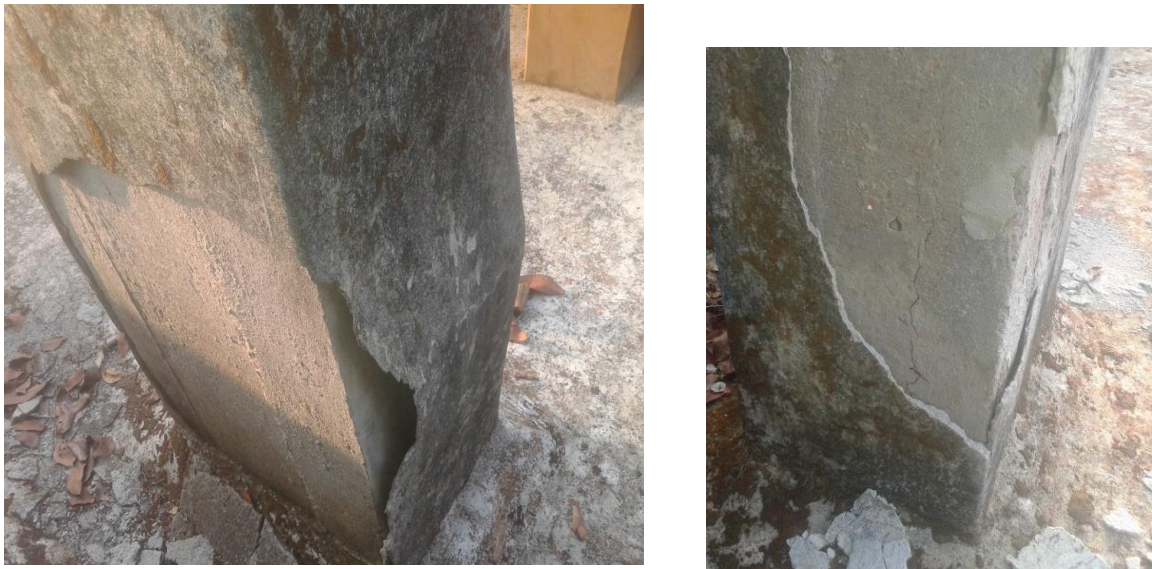
Figure 6.4: Damaged on column plaster

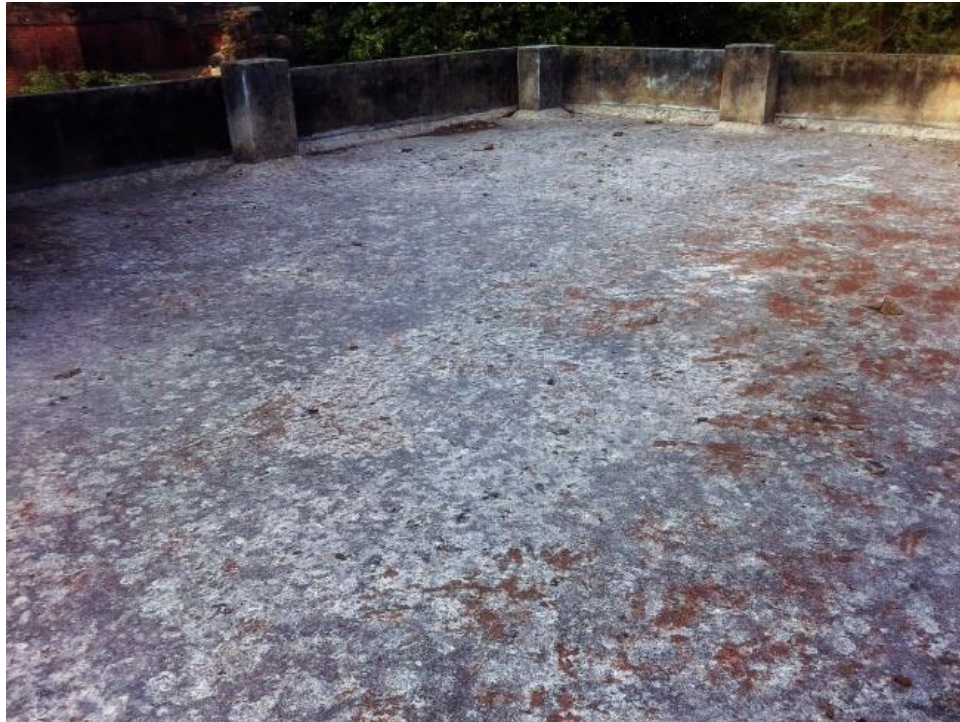
Figure 6.5: Existing roof condition

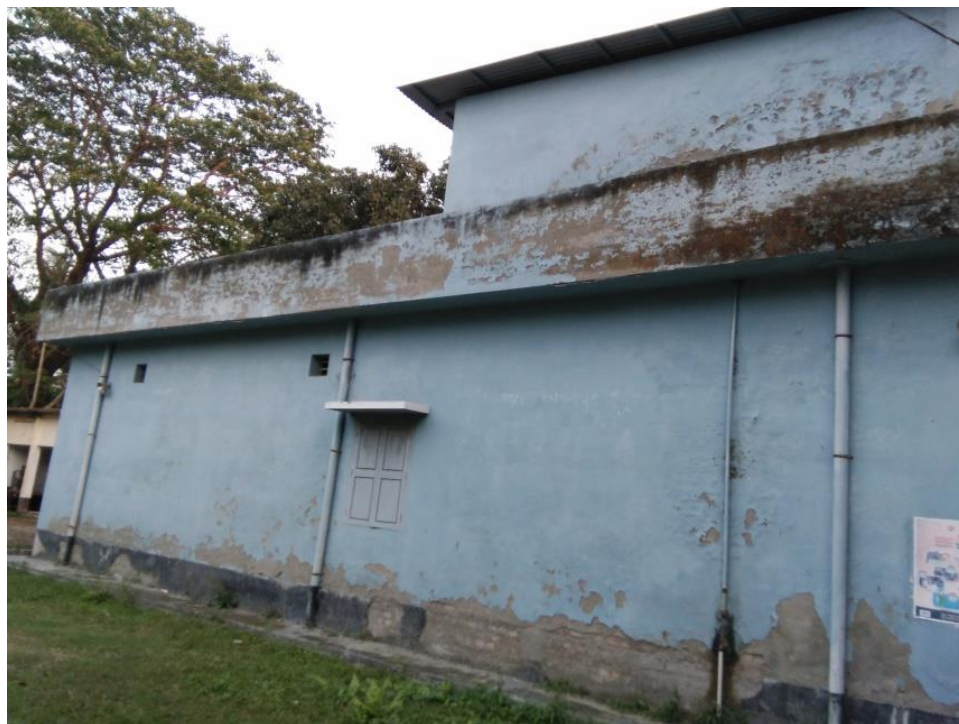
Figure 6.6: Outside paint condition

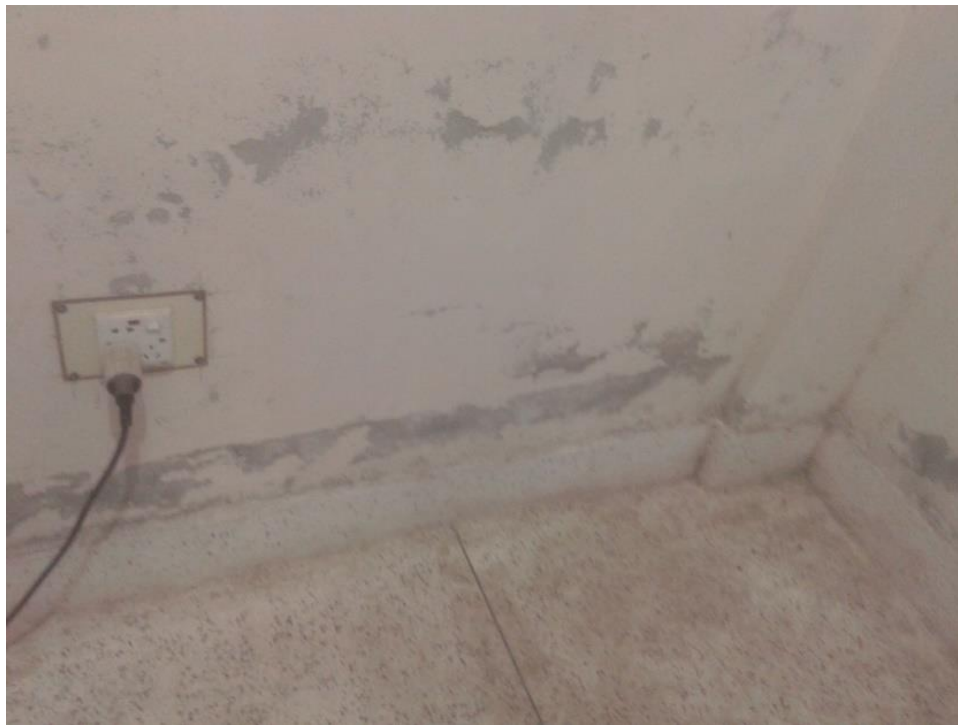
Figure 6.7: Dampness in interior wall of cold storage room

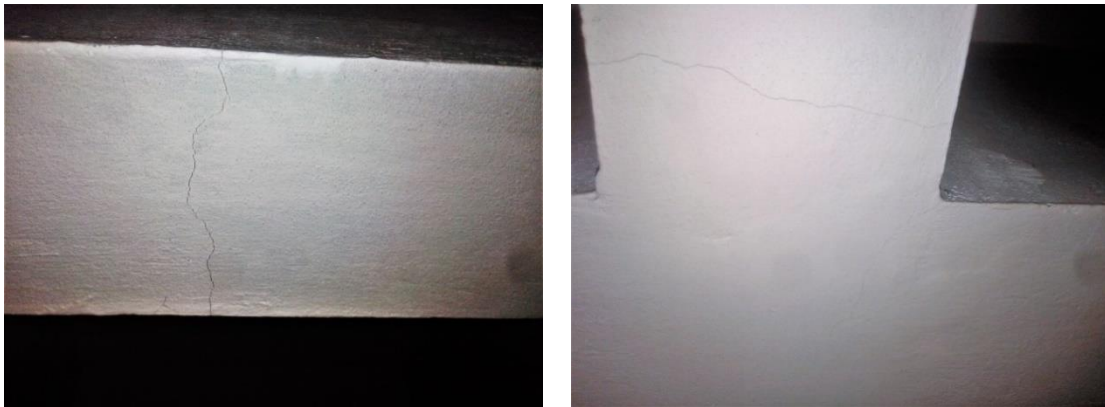
Figure 6.8: Crack in Waffle beam in cold storage room

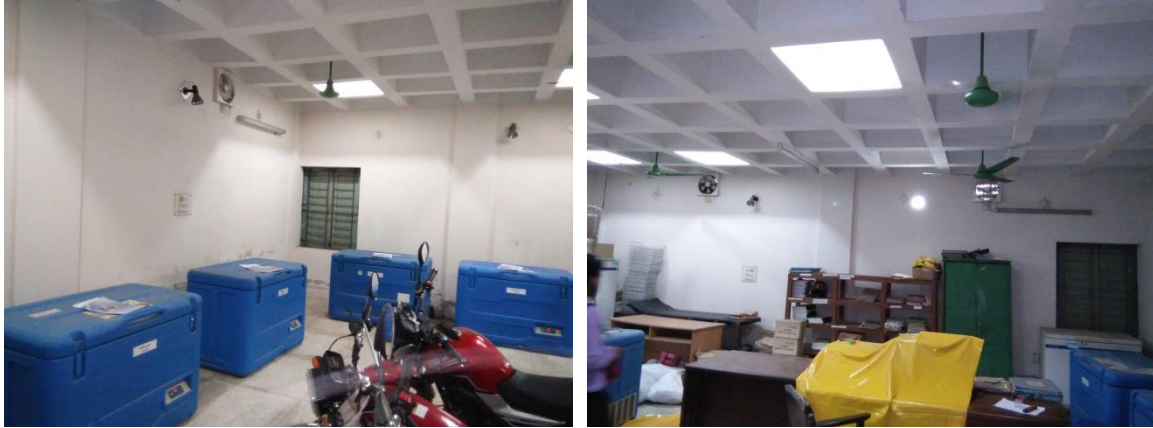
Figure 6.9: Existing vaccine storage room

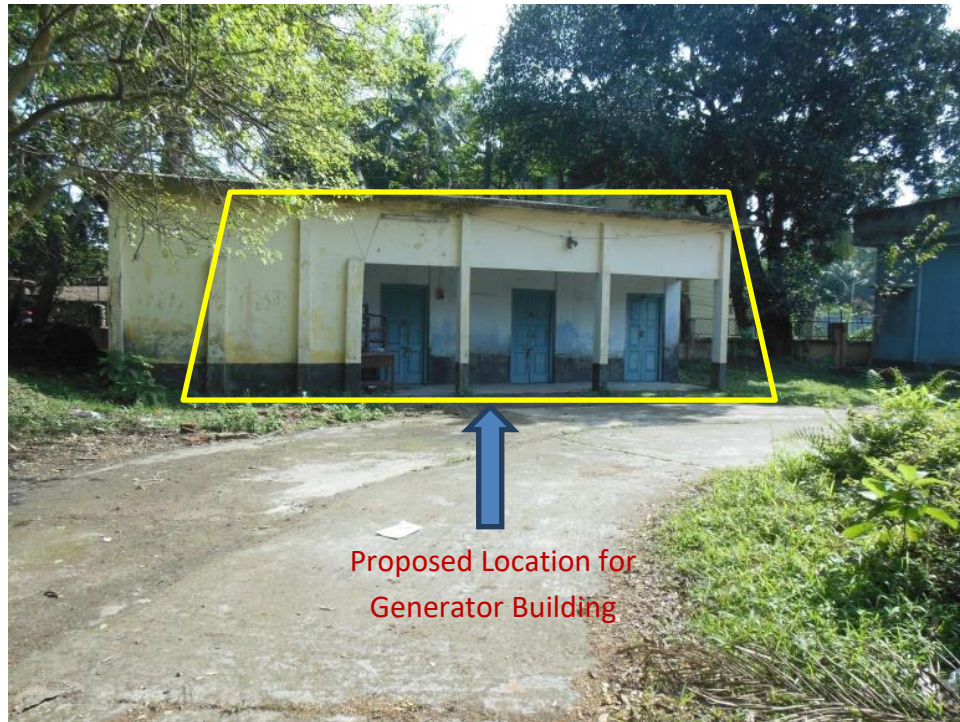
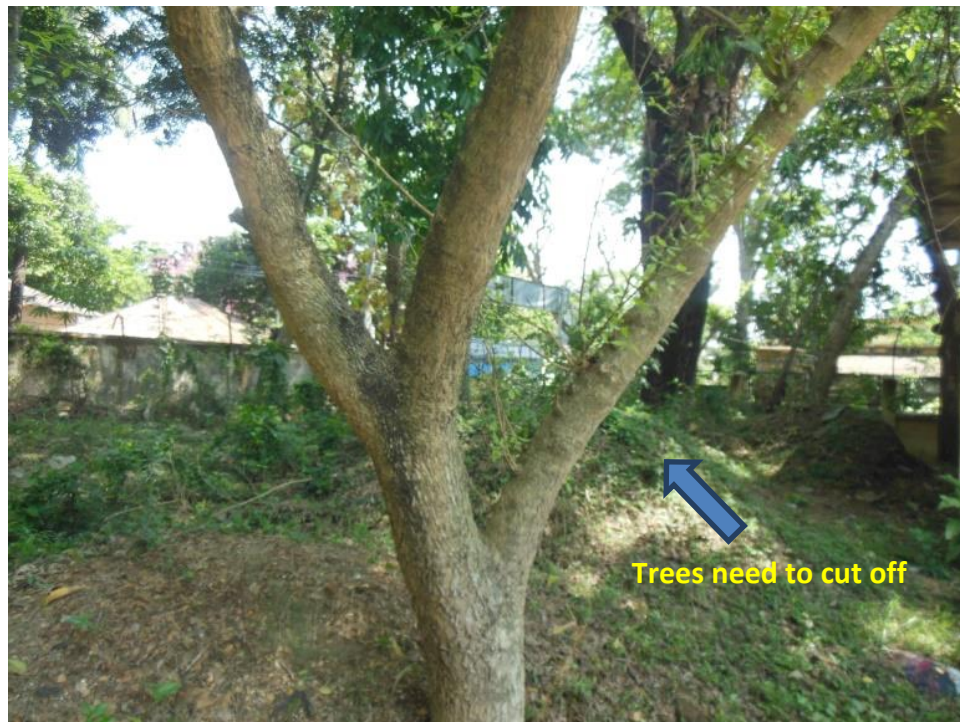
Figure 8.1: Proposed land for the construction of new EPI & generator building
