**GLOBAL ALLIANCE FOR VACCINES AND IMMUNIZATION (GAVI)  
HEALTH SYSTEM STRENGTHENING II (HSS-2) PROGRAMME**

***PRILIMINARY ASSESSMENT REPORT  
EPI BUILDING, HABIGANJ***

May 12, 2018

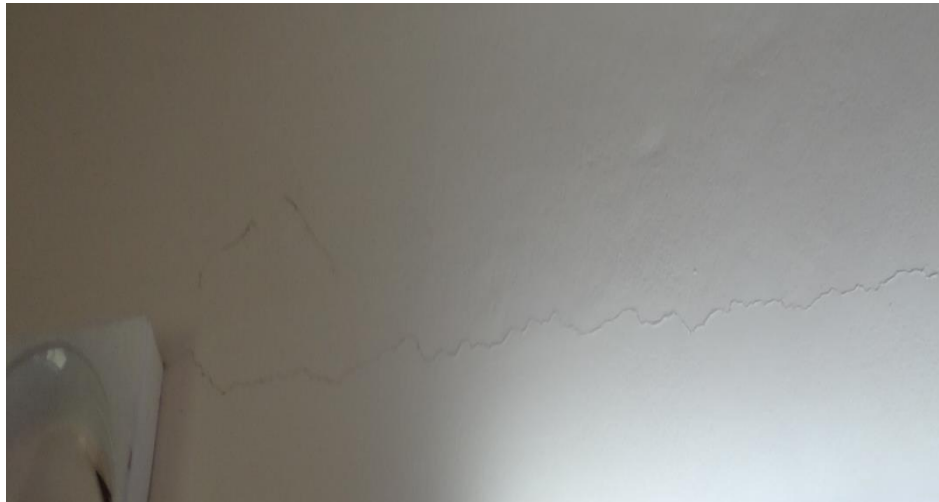
Figure 6.1: Partition wall plaster cracked

- Re-plastering is recommended for walls with minor cracks on plaster.
- Repaint of the existing outer side as well as inner part is recommended. To avoid corrosion; red oxide and enamel paint must be applied to the exposed reinforcement.

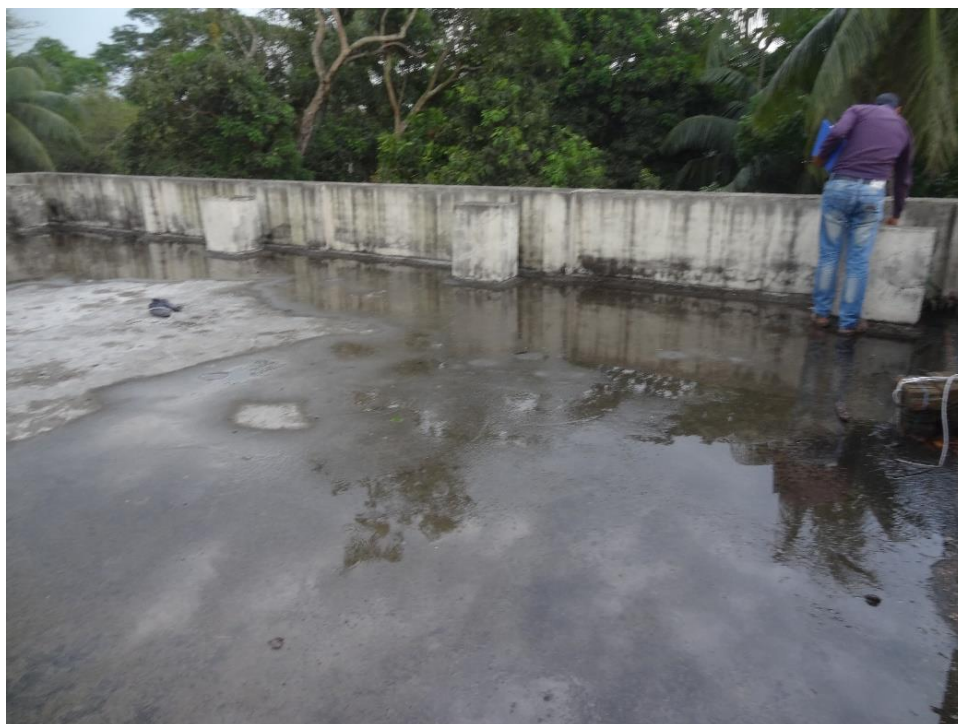
Figure 6.2: Existing Condition of Roof Slab

- Appropriate damp proofing measure should be taken in the affected area.
- Resurfacing is highly recommended for water logged area on the roof surface, because some spalling is found on the roof.

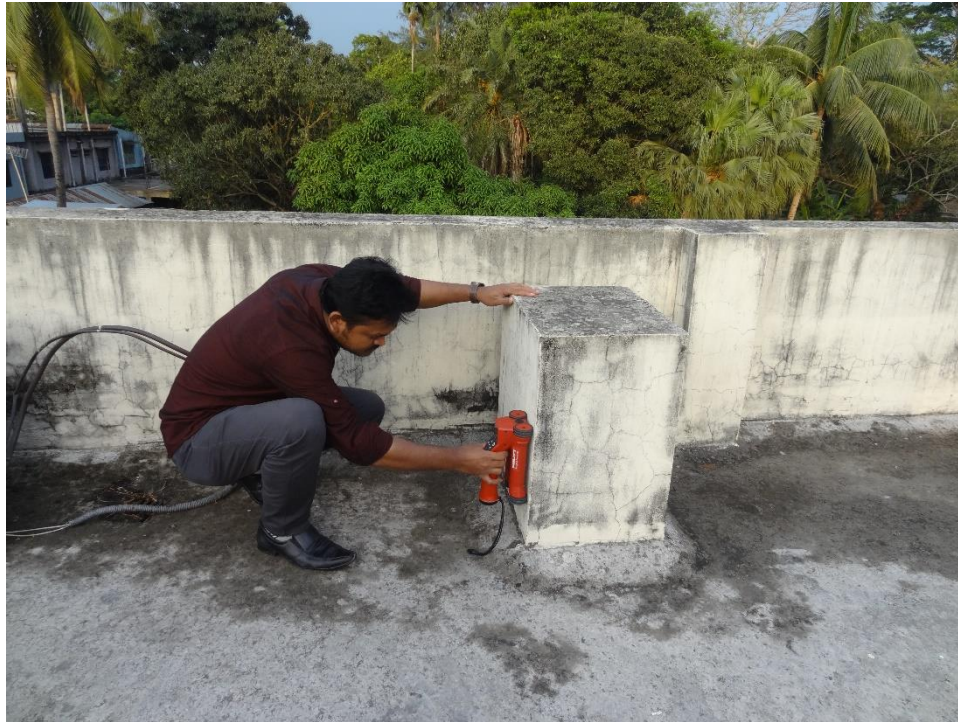
Figure 6.3: Checking Column Reinforcement and Spacing

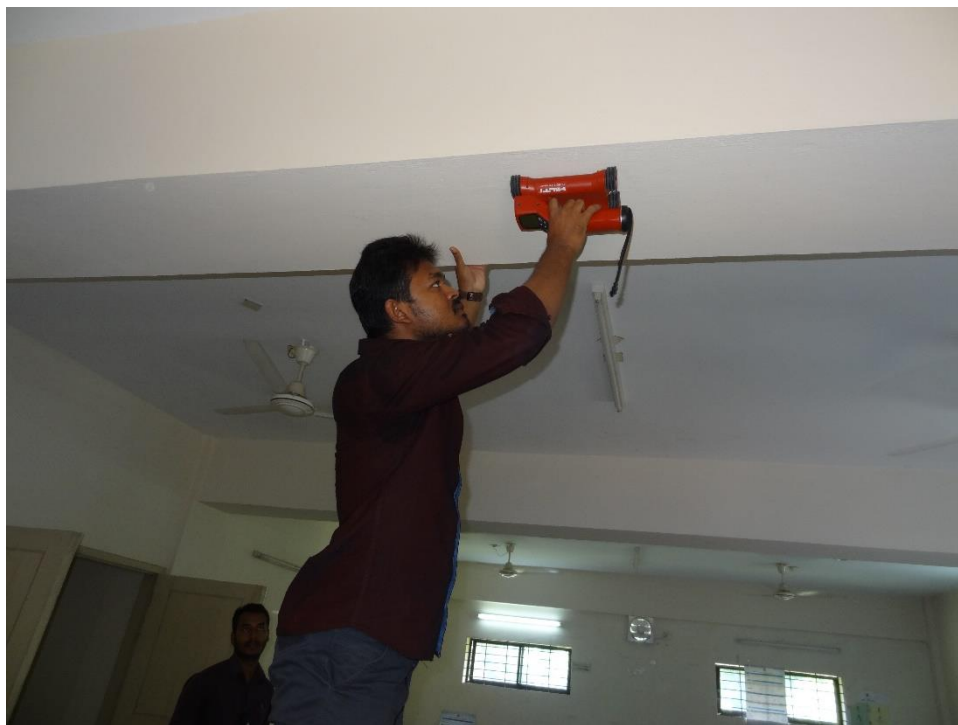
Figure 6.4: Checking Beam Reinforcement and Spacing

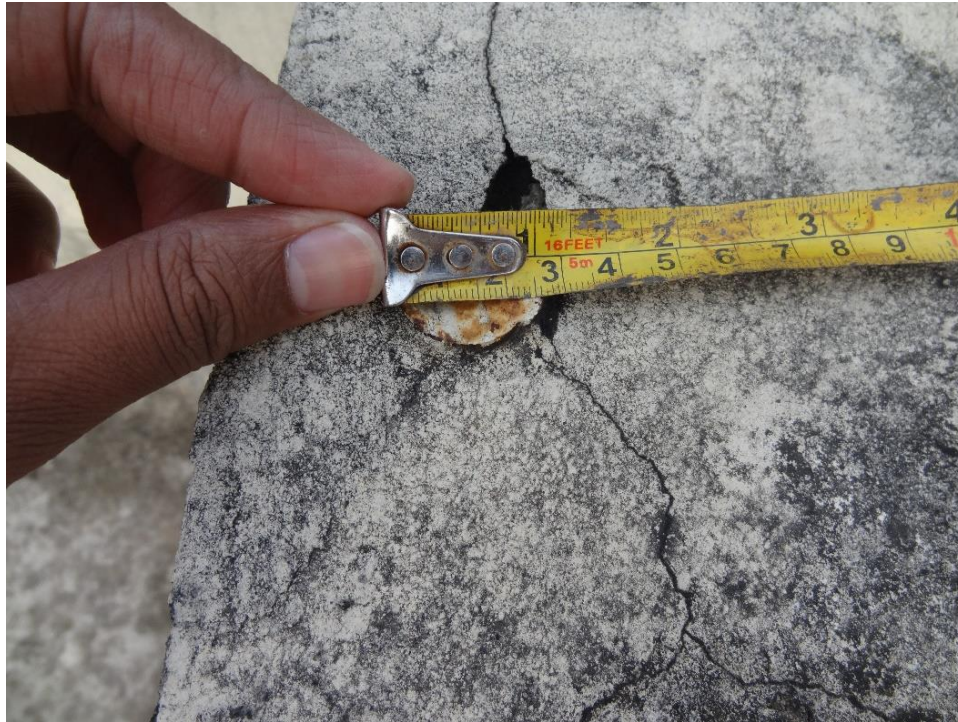
Figure 6.5: Exposed Rebar of roof false Column

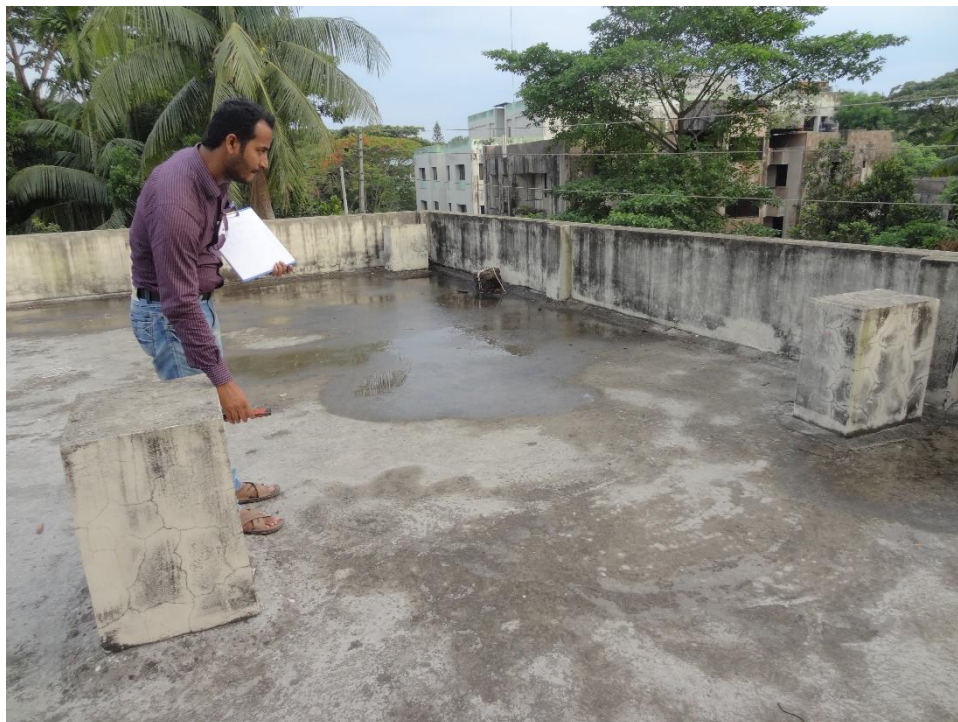
Figure 6.6: Checking of column to column spacing

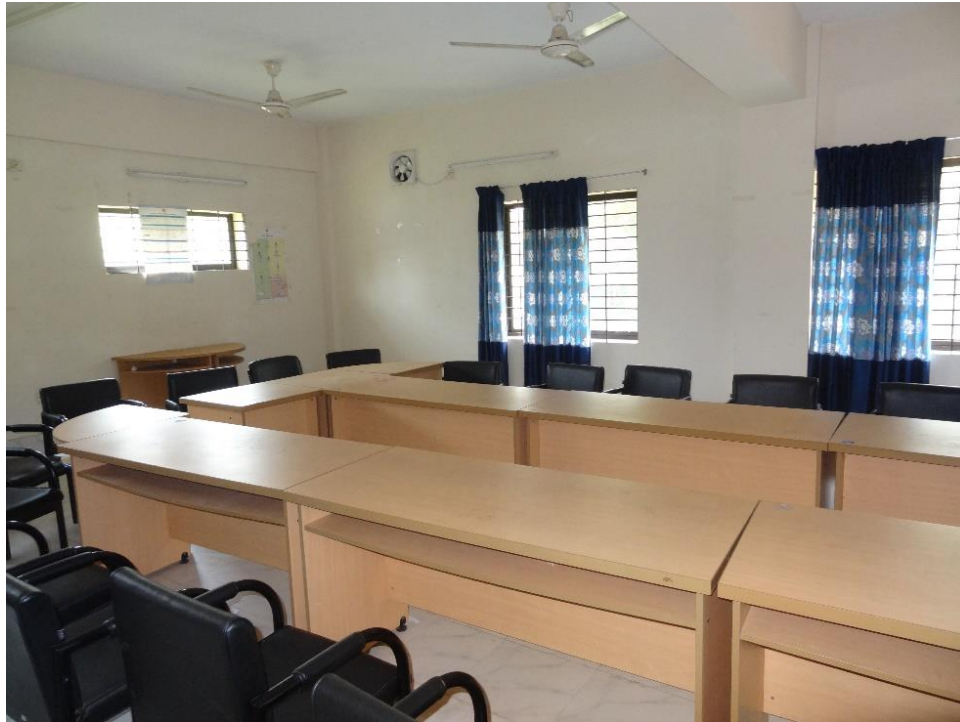
Figure 6.7: Existing Conference Room at 1<sup>st</sup> Floor

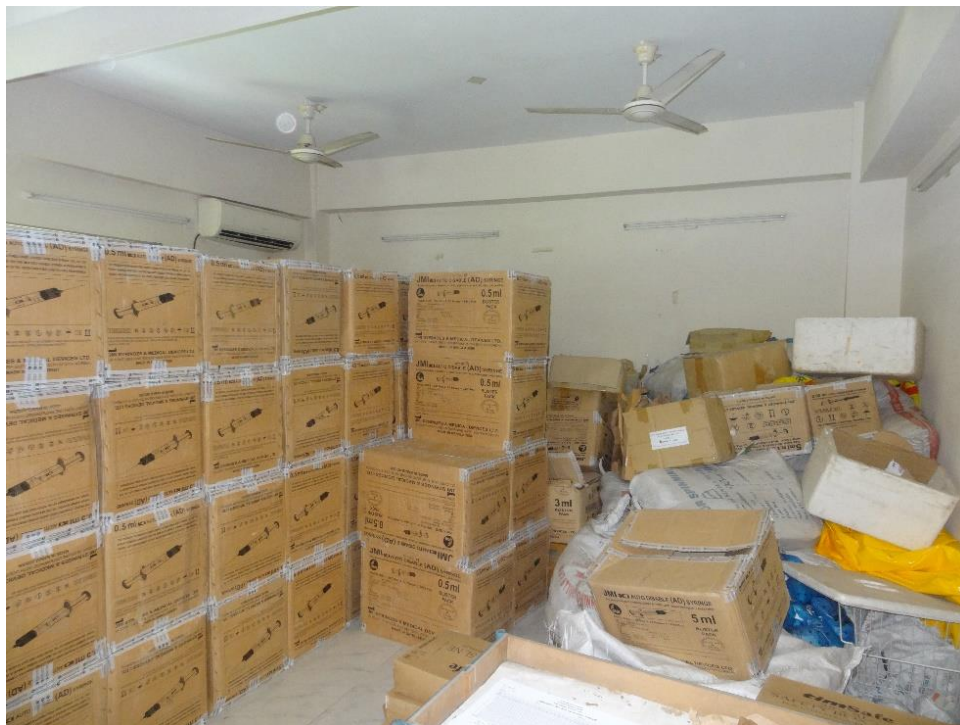
Figure 6.8: Existing Condition of Logistic Room at 1st floor

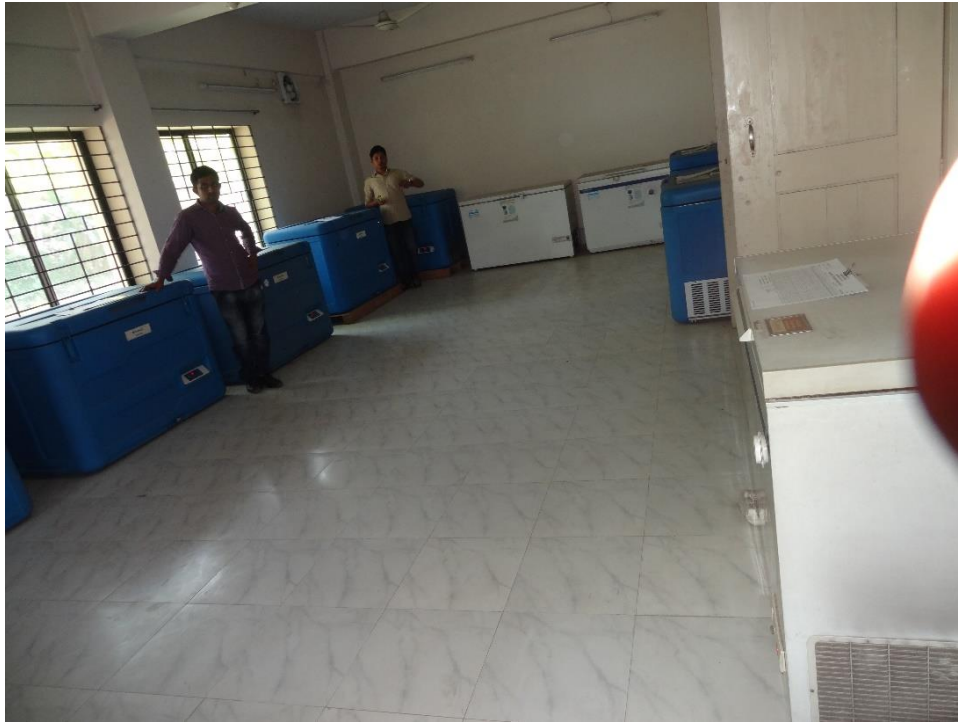
Figure 6.9: Existing Condition of Cold Room at Ground floor

- As per provided guideline of UNICEF, in order to accommodate 2 nos. of WIC, 2 nos. of Freezer and dry store room, the EPI cold room must be renovated.

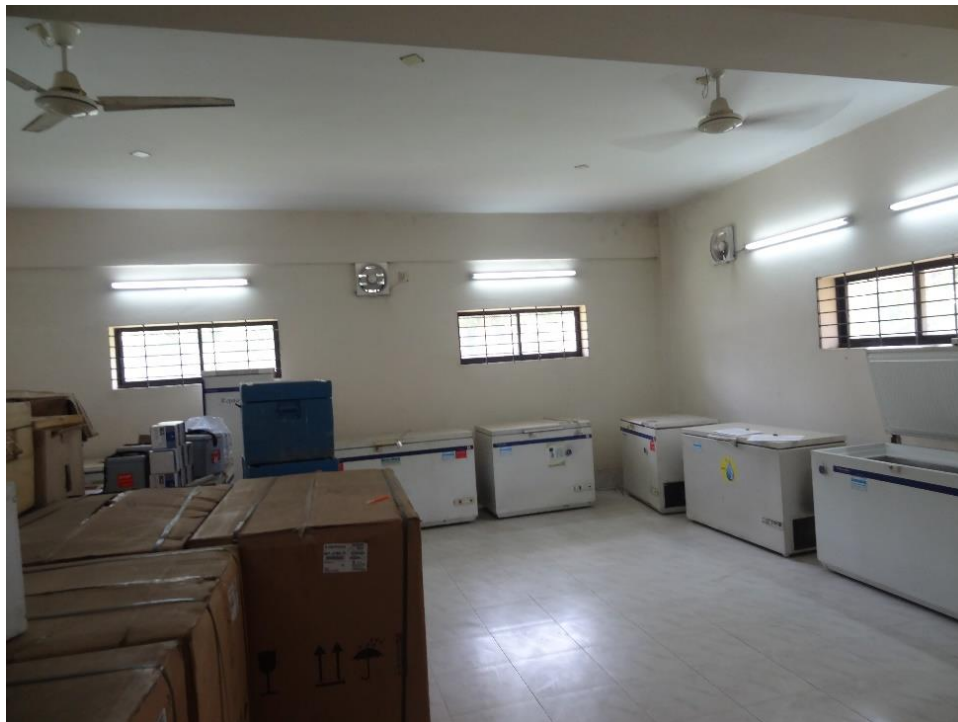
Figure 6.10: Existing Condition of Freezer Room at Ground floor

- It is mandatory to accommodate WIC, Precooling room, Freezer room and Monitoring room in ground floor. Dry store may remain at 1<sup>st</sup> floor.
- Recommended wash basin (sink) can also be installed within the renovated freezer room.

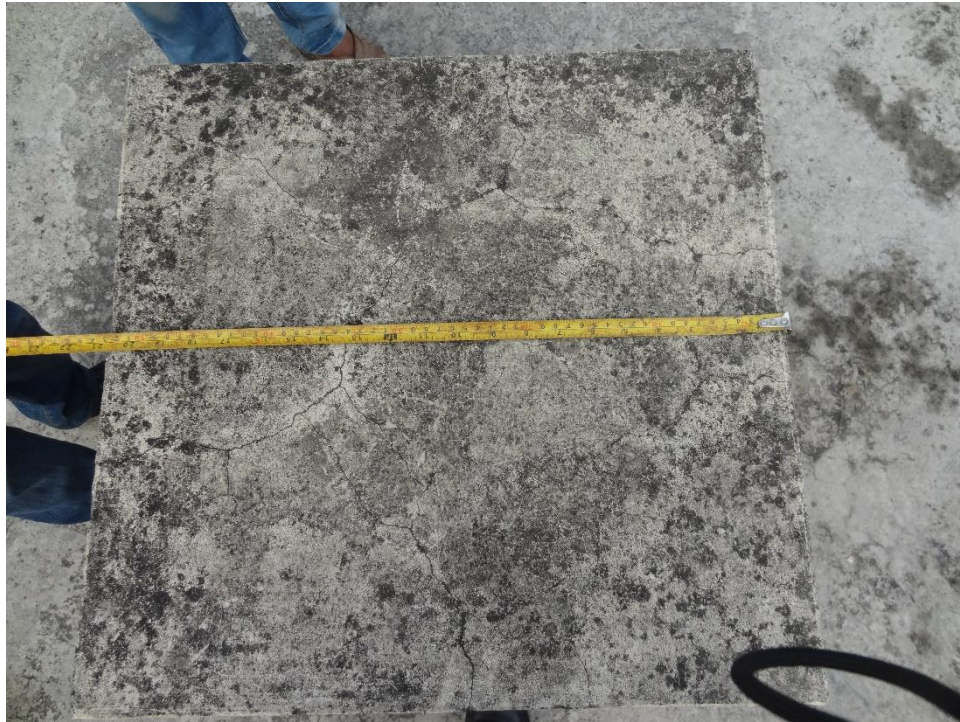
Figure 6.11: Measuring False Column Dimension

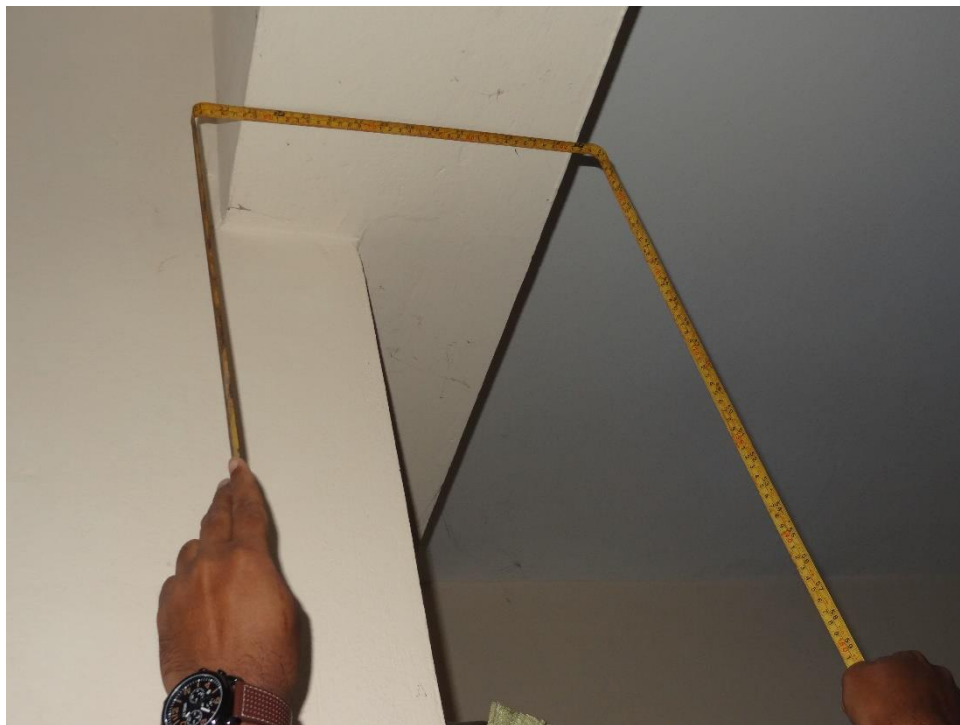
Figure 6.12: Measuring Beam Width

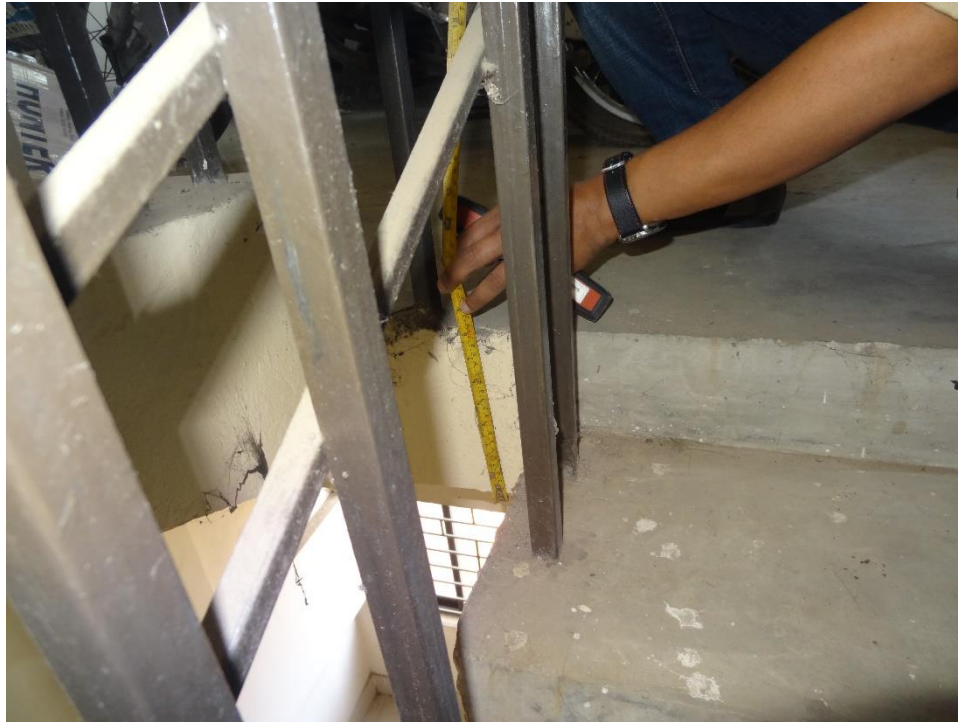
Figure 6.13: Measuring waist slab thickness

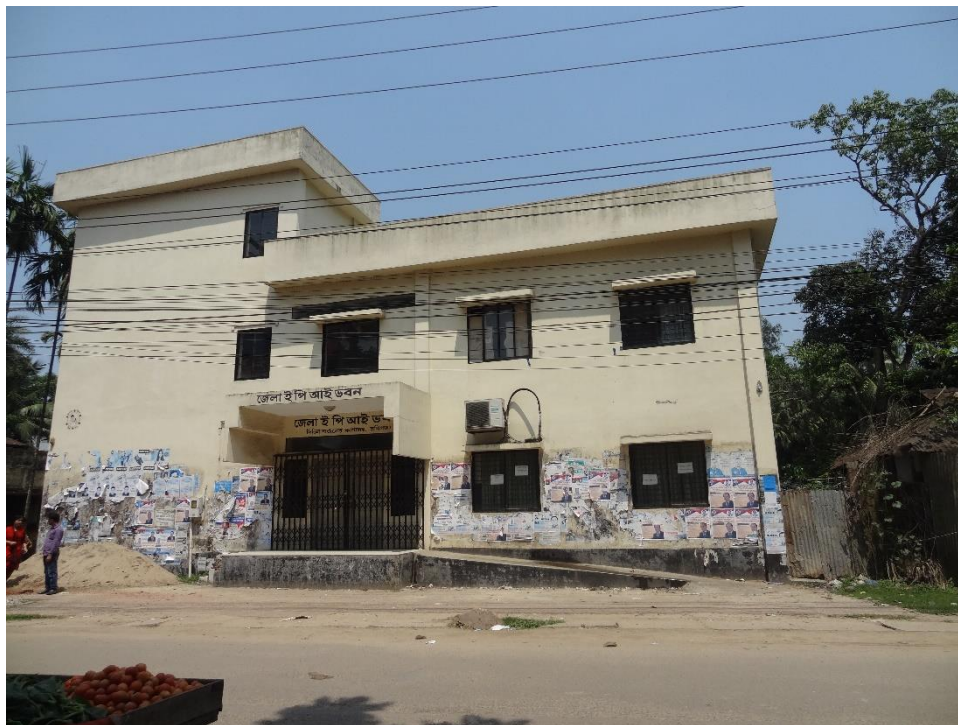
Figure 6.14: Front side Building Condition

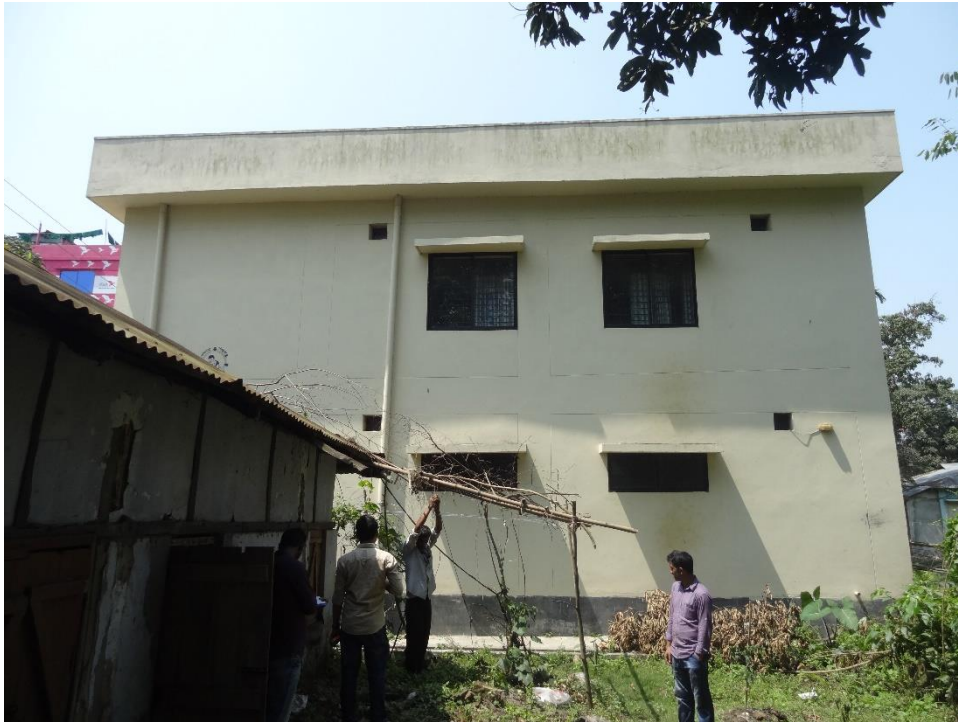
Figure 6.15: Building South Side View

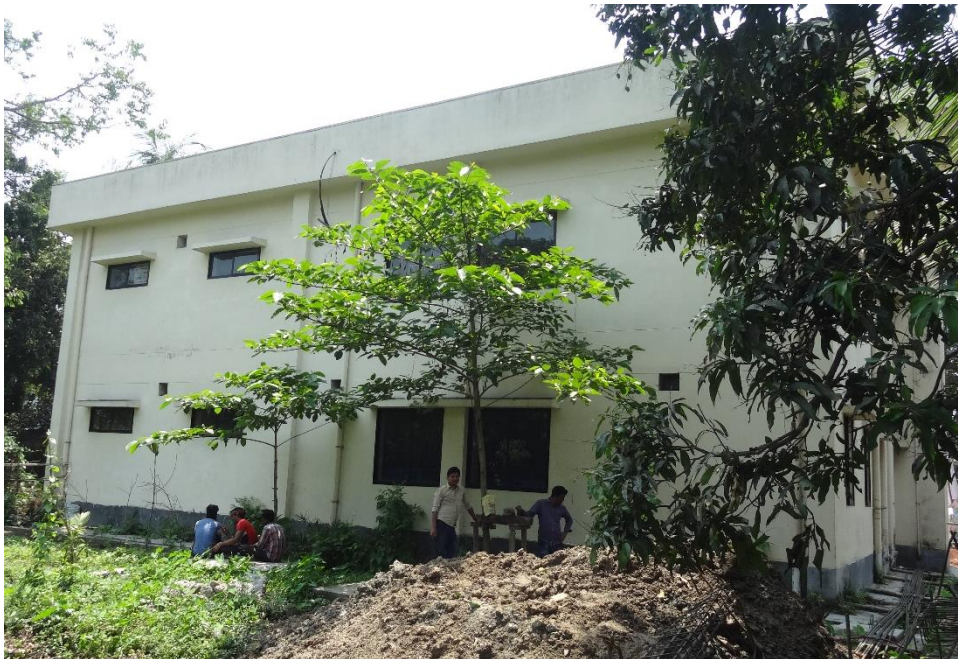
Figure 6.16: Backside Building Condition

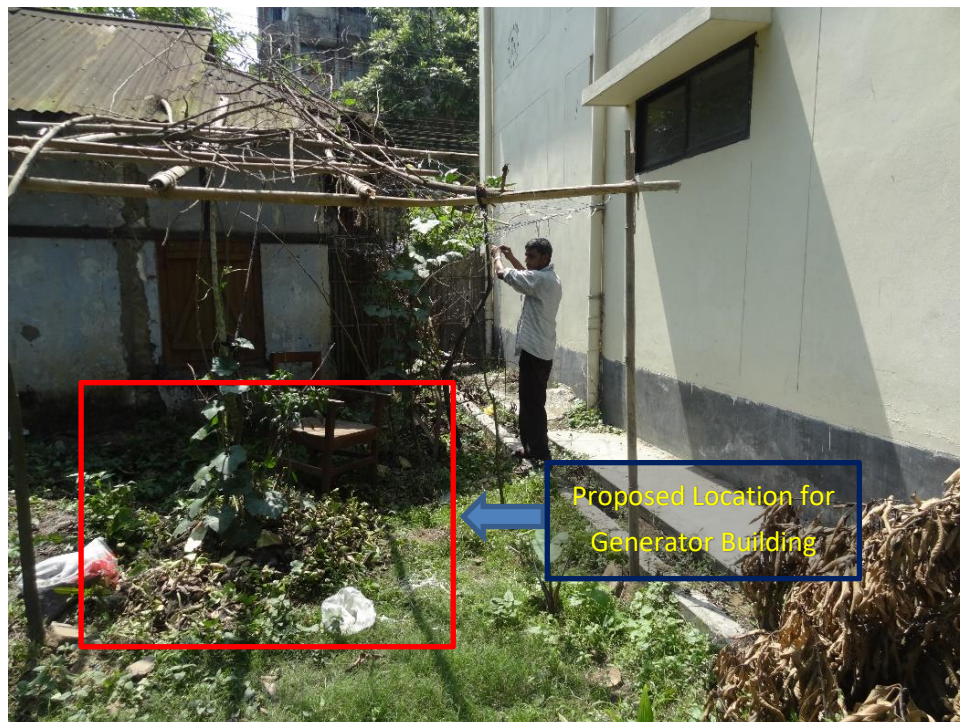
Figure 8.1: Proposed land for the construction of new generator building (in South side)

- A piece of land is required for the construction of new generator room. In the south side of EPI building, land is available to construct a new generator room.

- For Physical implementation of new generator building, an unused brick building with tin shed need to be broken from the proposed site. CS sir ensured us he will help us about site clearing issue as well as removal of unused old brick tin shed structure.
