**GLOBAL ALLIANCE FOR VACCINES AND IMMUNIZATION (GAVI)
HEALTH SYSTEM STRENGTHENING II (HSS-2) PROGRAMME**

***PRILIMINARY ASSESSMENT REPORT
EPI BUILDING, KHAGRACHARI***

May 12, 2018

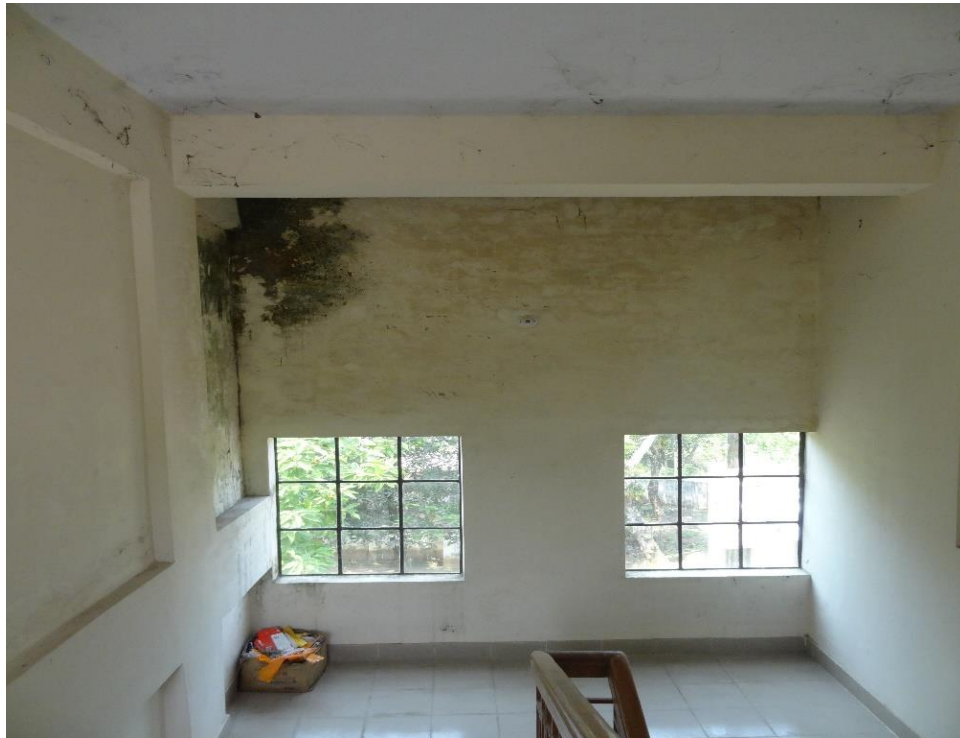
Figure 6.1: Partitions wall affected by moss at stair landing Portion

- Appropriate damp proofing measure should be taken in affected area and roof resurfacing.
- Resurfacing is highly recommended for water logged area on the roof surface, because some spalling is found on the roof.
- Re-plastering is recommended for walls with minor cracks on plaster.
- Repaint of the existing outer side as well as inner part is recommended.
- Existing SDB of 1st floor can be used. But separate electrical SDB are recommended for ground floor (WIC).

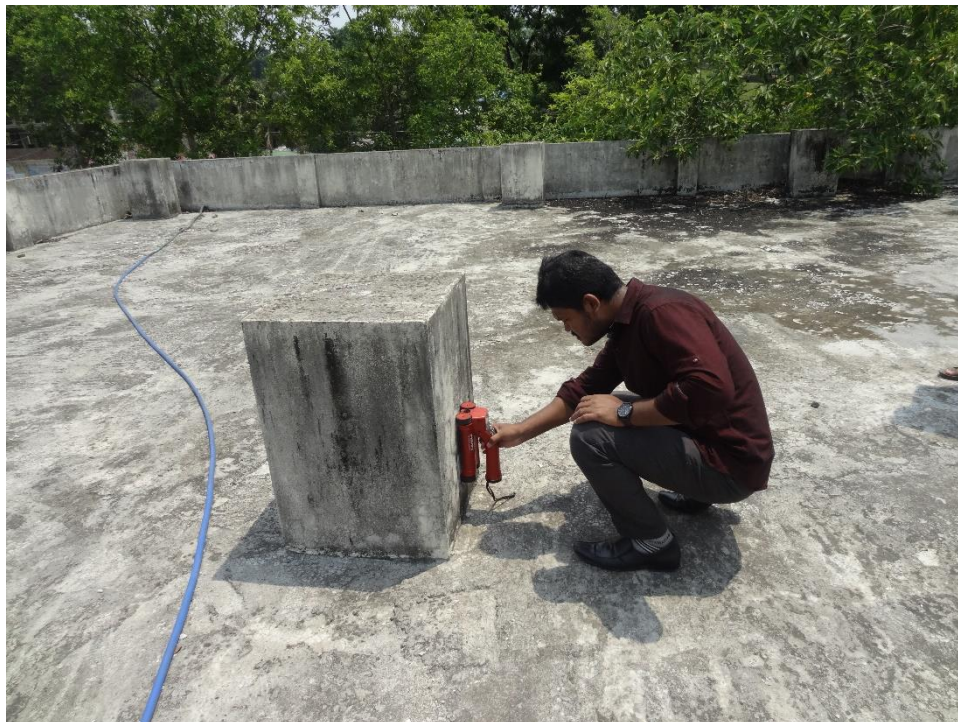
Figure 6.2: Checking Column Reinforcement and Spacing

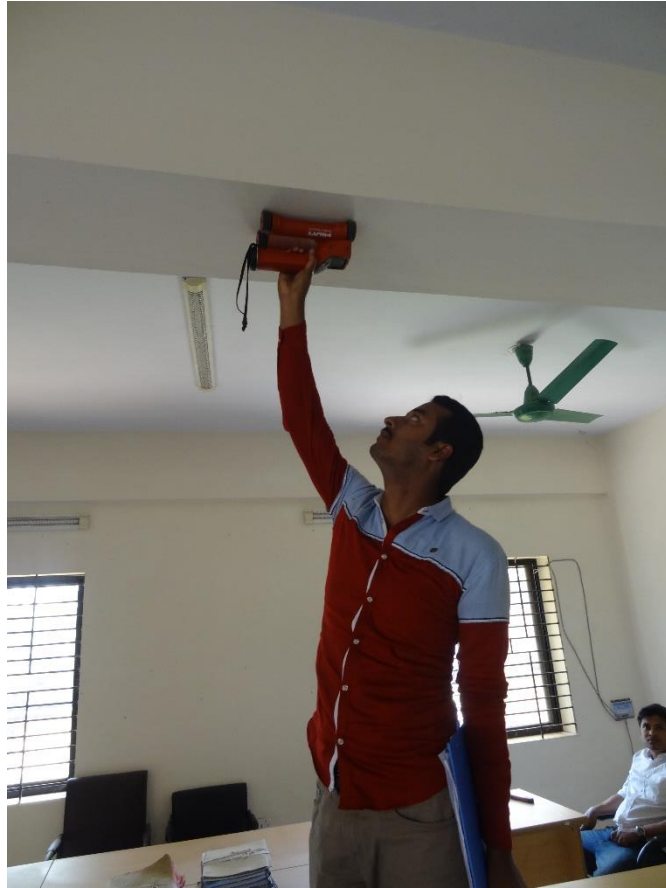
Figure 6.3: Checking Beam Reinforcement and Spacing

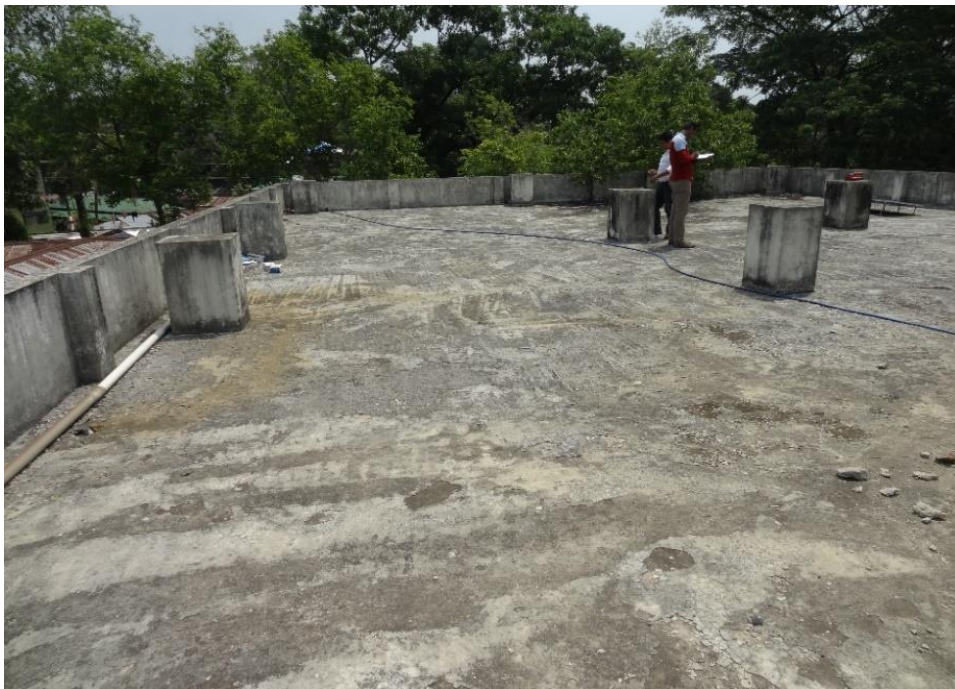
Figure 6.4: Existing Condition of Roof Slab

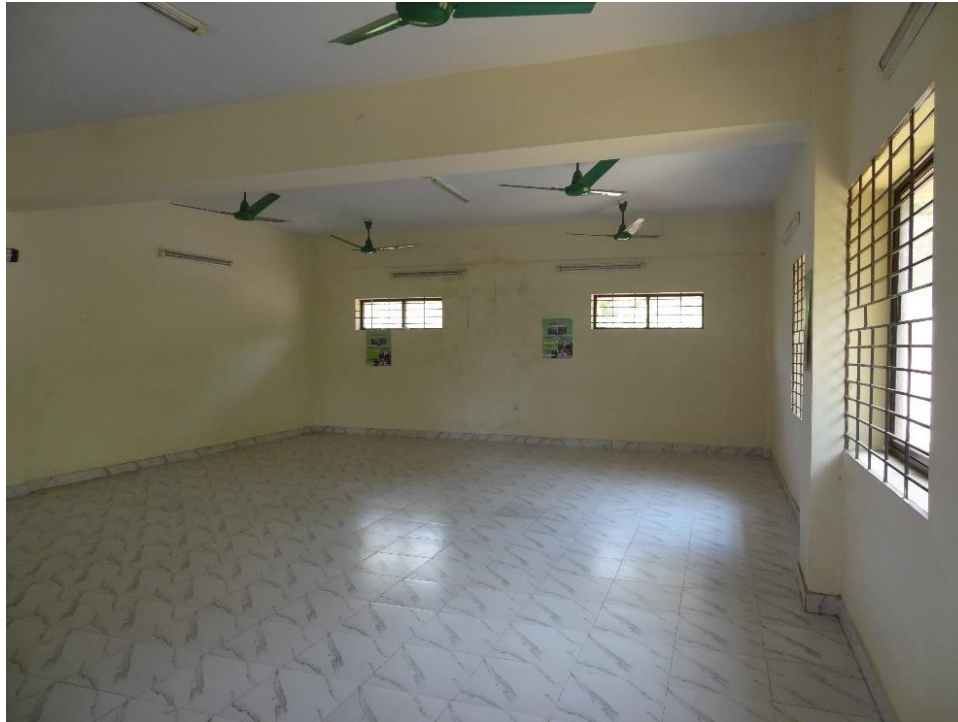
Figure 6.5: Existing Conference Room with dampness in side wall at 1st Floor

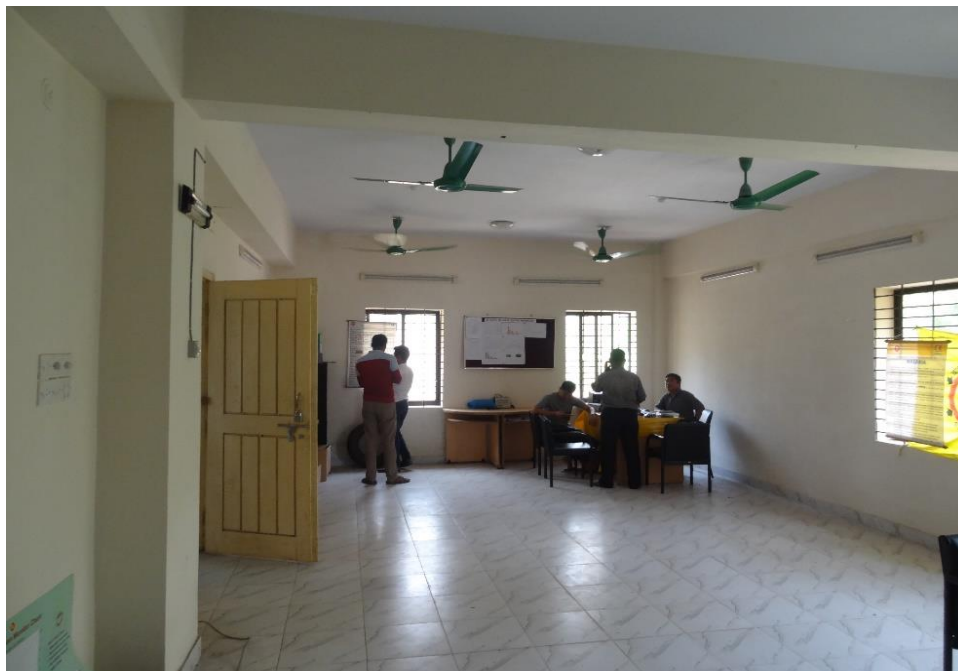
Figure 6.6: Existing Condition of WHO/SIMO Room at 1st floor

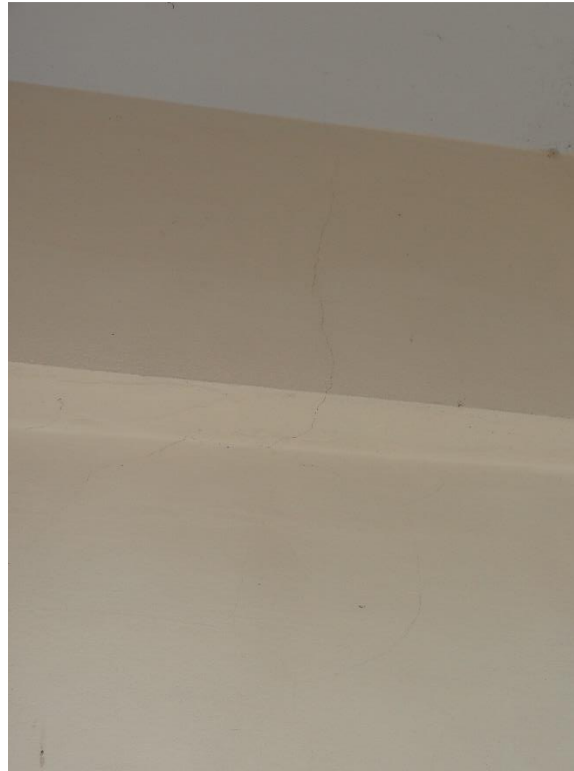
Figure 6.7: Visible minor cracks in the plaster of beam (1st floor)

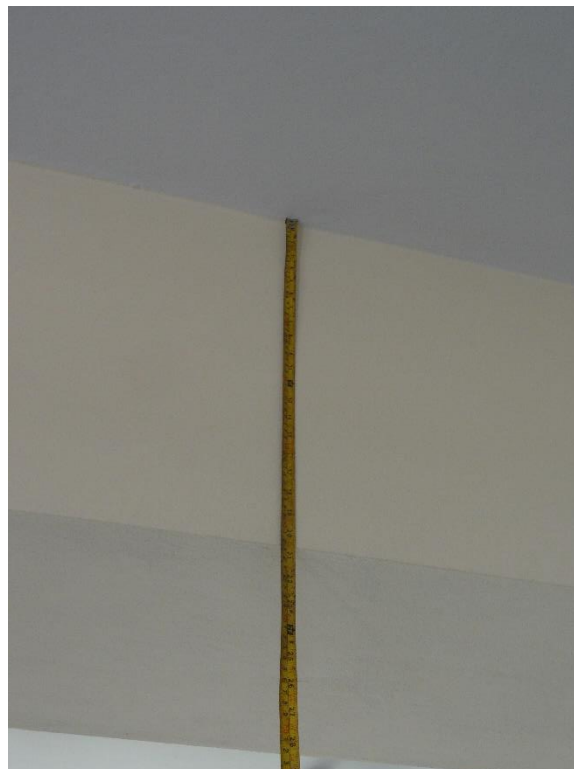
Figure 6.8: Measurement taking of beam depth (1st floor)

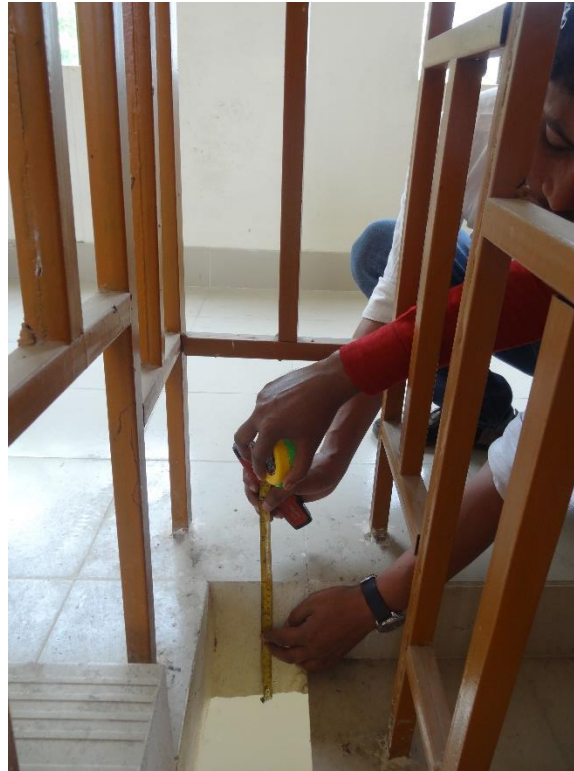
Figure 6.9: Measurement taking of waist slab thickness (1st floor)

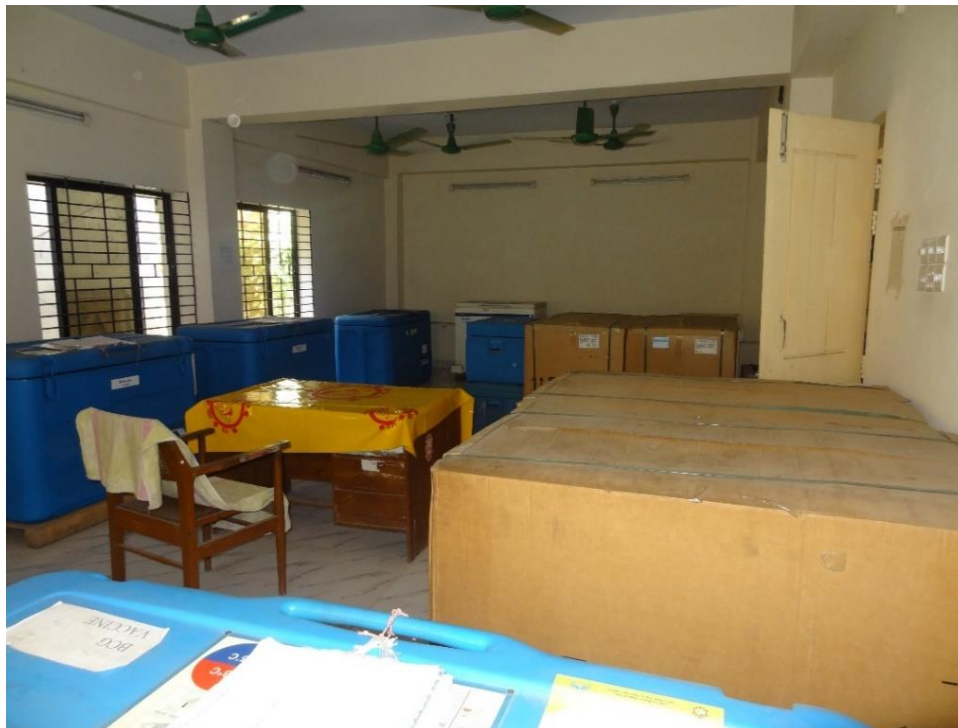
Figure 6.10: Existing Condition of Vaccine Storage Room at Ground floor

- As per provided guideline of UNICEF, in order to accommodate 1 nos. of WIC, 1 nos. of freezer and dry store room, the EPI cold room must be renovated.
- It is mandatory to accommodate WIC, precooling room, freezer room and monitoring room in ground floor. Dry store may remain at 1st floor.
- Recommended wash basin (sink) can also be installed within the renovated freezer room.

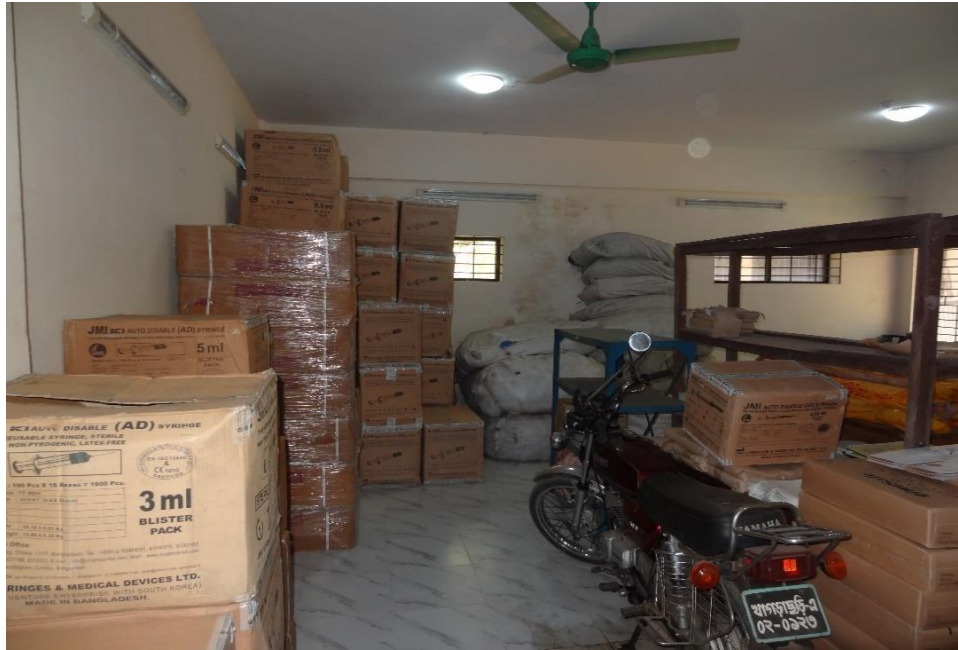
Figure 6.11: Existing Condition of Logistic Room at Ground floor

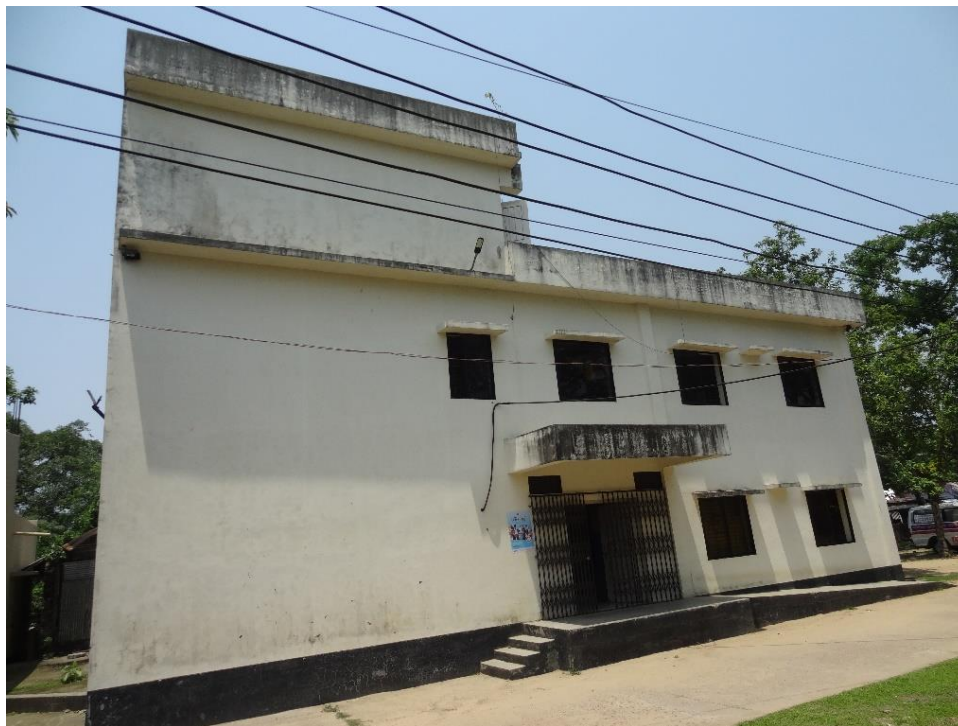
Figure 6.12: Front side Building Condition

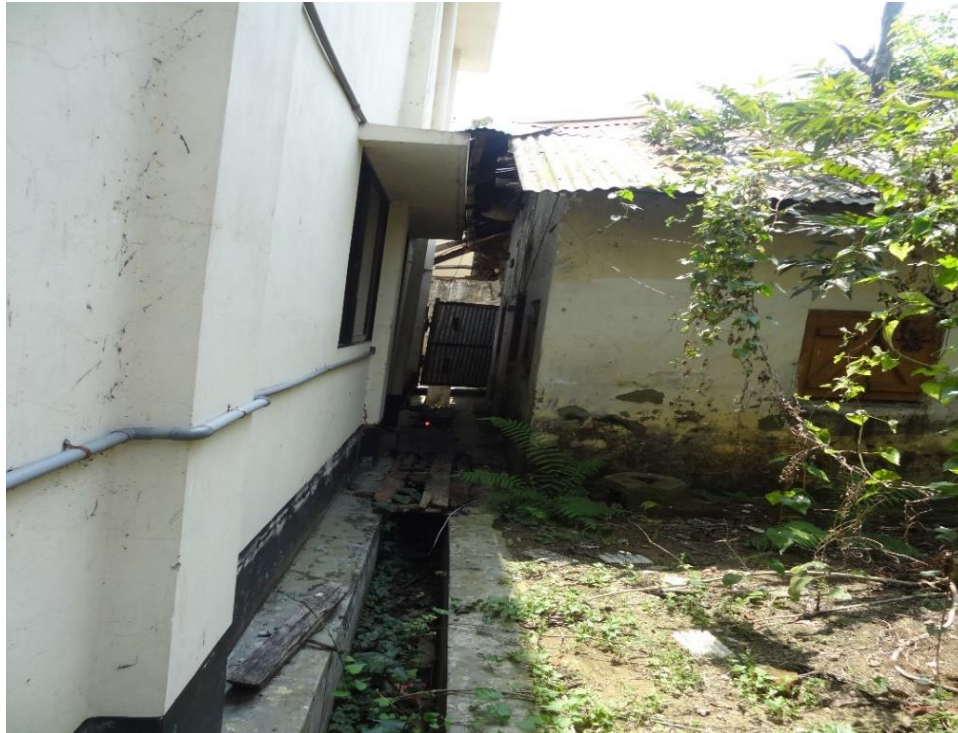
Figure 6.13: Backside Building Condition

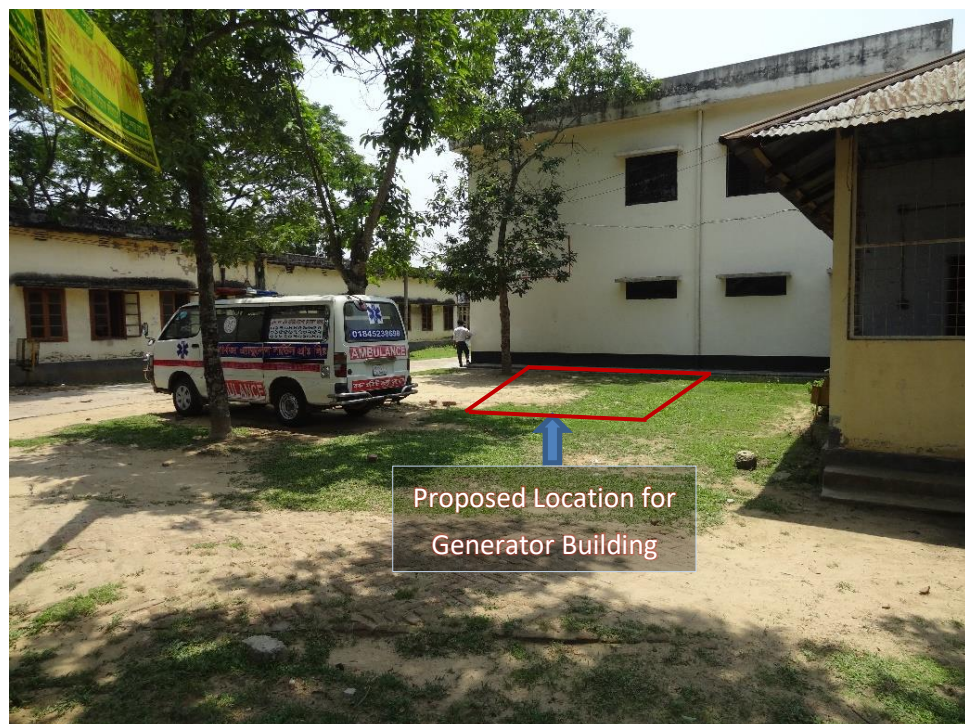
Figure 8.1: Proposed land for new generator room construction.

- A piece of land is required for the construction of new generator room. In the east side of EPI building, land is available to construct a new generator room. We chose this land for generator room and discussed with acting civil surgeon over the phone about whether we can use this land or not as a generator room. And he confirmed us that they have no problem from the CS office about using this land for a new generator room which will supply uninterrupted electricity to the WIC room.

- No site clearing issue is required for this proposed land.
