**GLOBAL ALLIANCE FOR VACCINES AND IMMUNIZATION (GAVI)  
HEALTH SYSTEM STRENGTHENING II (HSS-2) PROGRAMME**

***PRILIMINARY ASSESSMENT REPORT  
EPI BUILDING, KUSHTIA***

May 12, 2018

**Environment & Infrastructure Management Solution (EIMS) Limited**

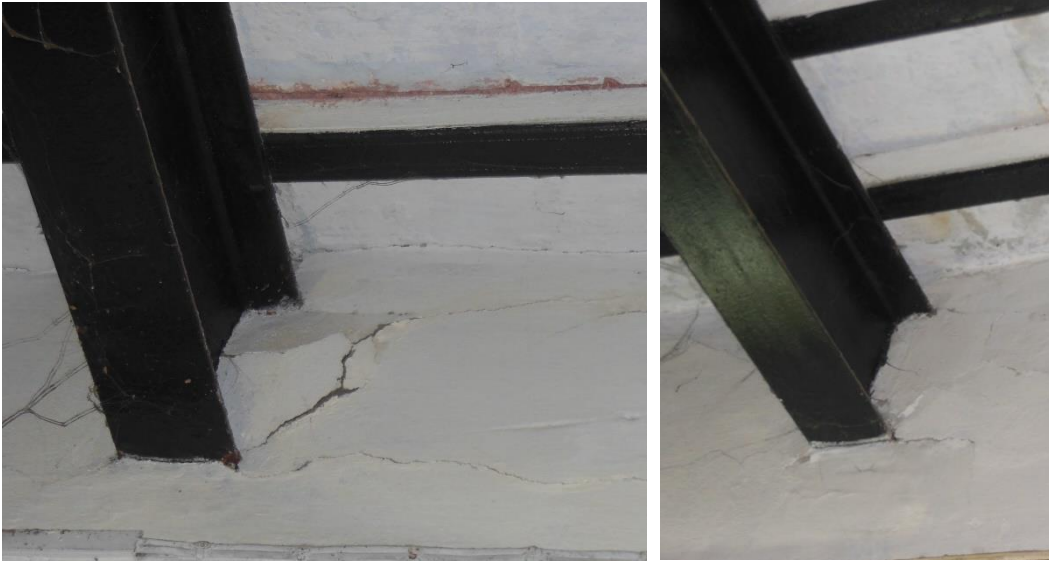
- Some cracks were found on the load bearing masonry wall of the building.
- Dampness was found on load bearing masonry walls and roof slab.
- Discolored of paint both in inner and outer side are found.
- No major settlement was found in the building by observing interior wall.

Figure 6.1: Cracks in load bearing wall below steel beam

- As existing building is very old, many cracks are visible, so the building is not in usable condition.
- It can be demolished or can be used for any other purpose.
- Since there is no free space inside the Civil Surgeon boundary, and it is not possible to manage the other rooms for fulfilling the present space requirement for 2 WIC, 2 freezers, Precooling room, Monitoring room, CCT room, Office room, dry store room and Generator room in existing Civil Surgeon building or boundary, New land is needed for construction of new EPI Building and Generator room.
- It is mandatory to accommodate WIC, Precooling room, Freezer room and Monitoring room in ground floor. Dry store may remain at 1<sup>st</sup> floor.
- From the above observations, new EPI and generator building is recommended.

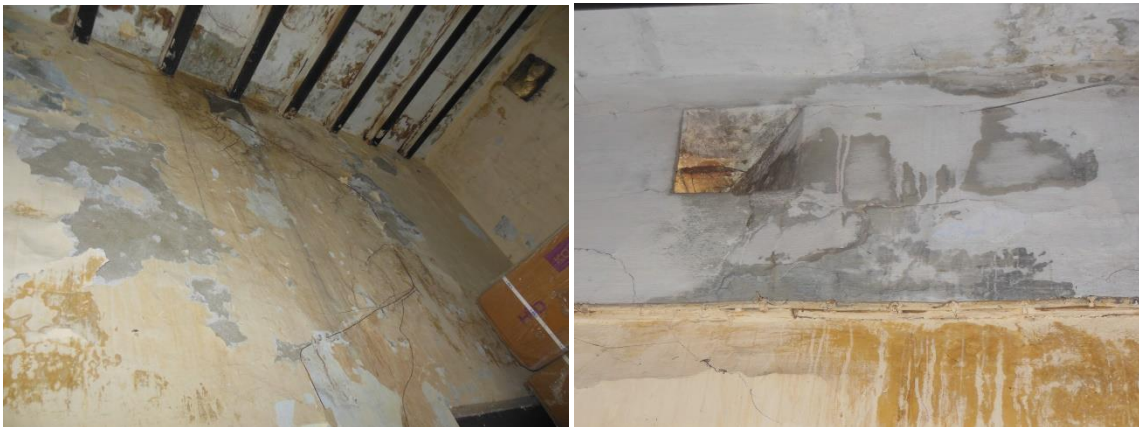
Figure 6.2: Dampness in load bearing wall

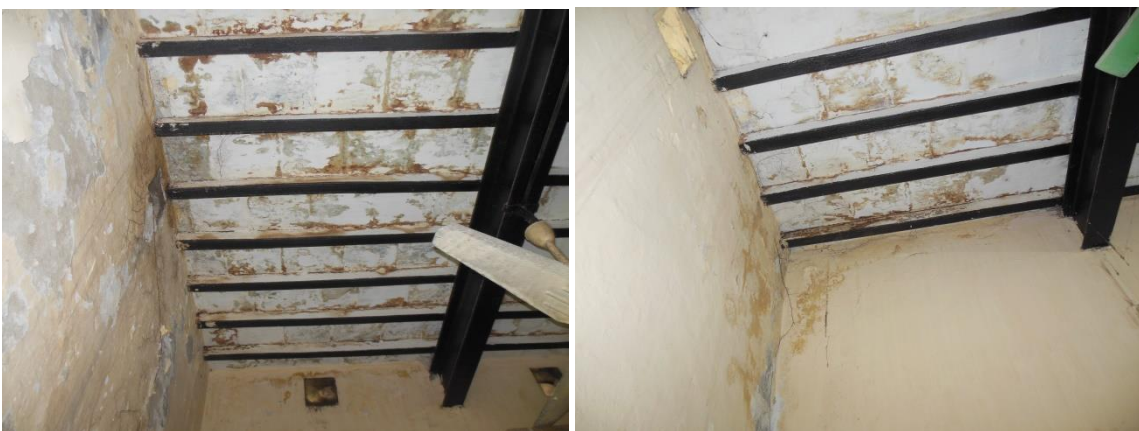
Figure 6.3: Dampness in roof slab

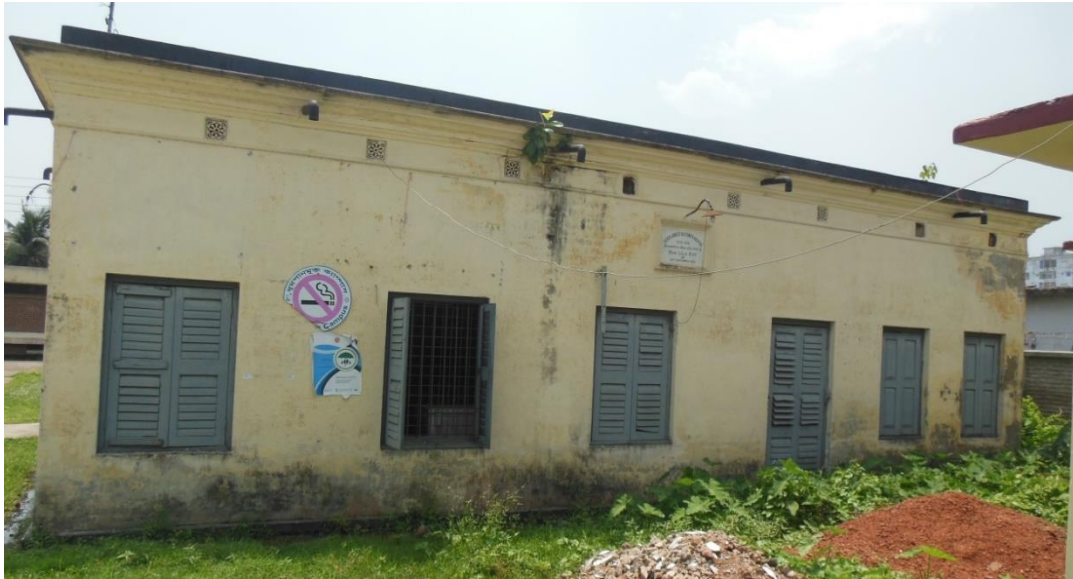
Figure 6.4: Back side condition of building

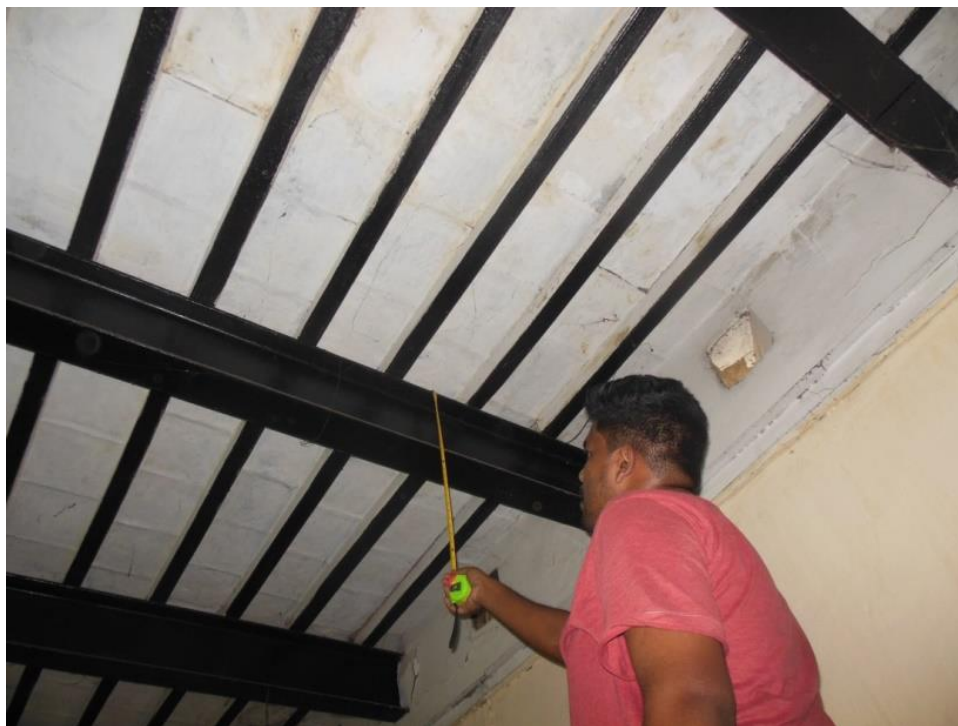
During the site visit some physical dimensions were measured for the building. The building is a load bearing masonry wall system. The roof is concrete slab having primary structural steel beam of size 250mmx125mmx10mm and secondary wooden beam. The thicknesses of both internal and external partition walls are found 250 mm.

Figure 6.5: Measuring physical dimension of steel beam

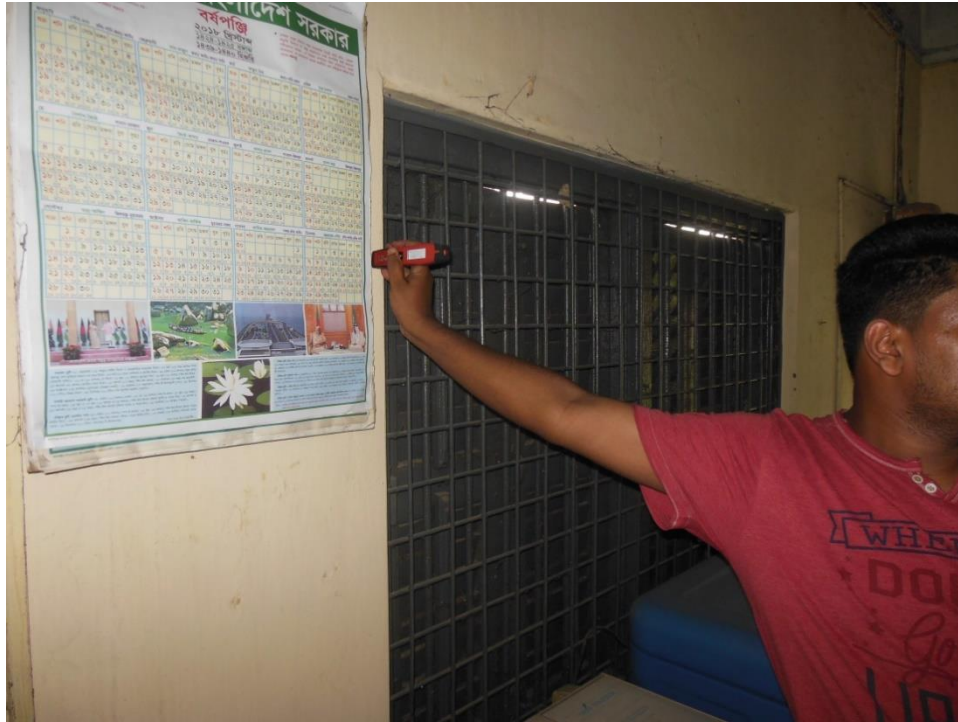
Figure 6.6: Measuring physical dimension of the building using laser meter

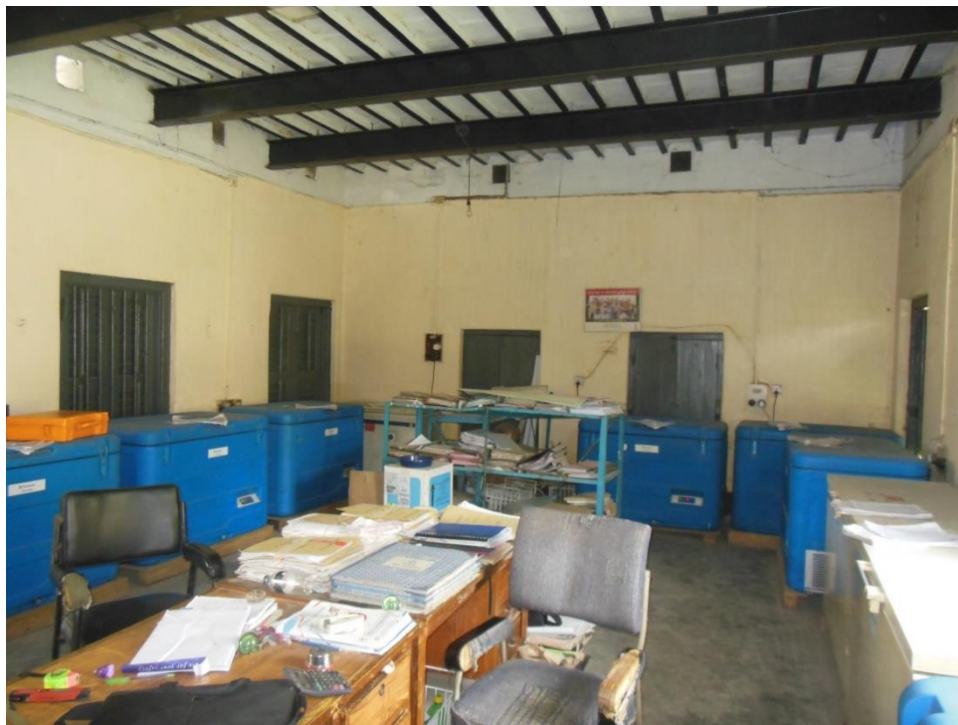
Figure 6.7: Existing Vaccine Storage Room Condition

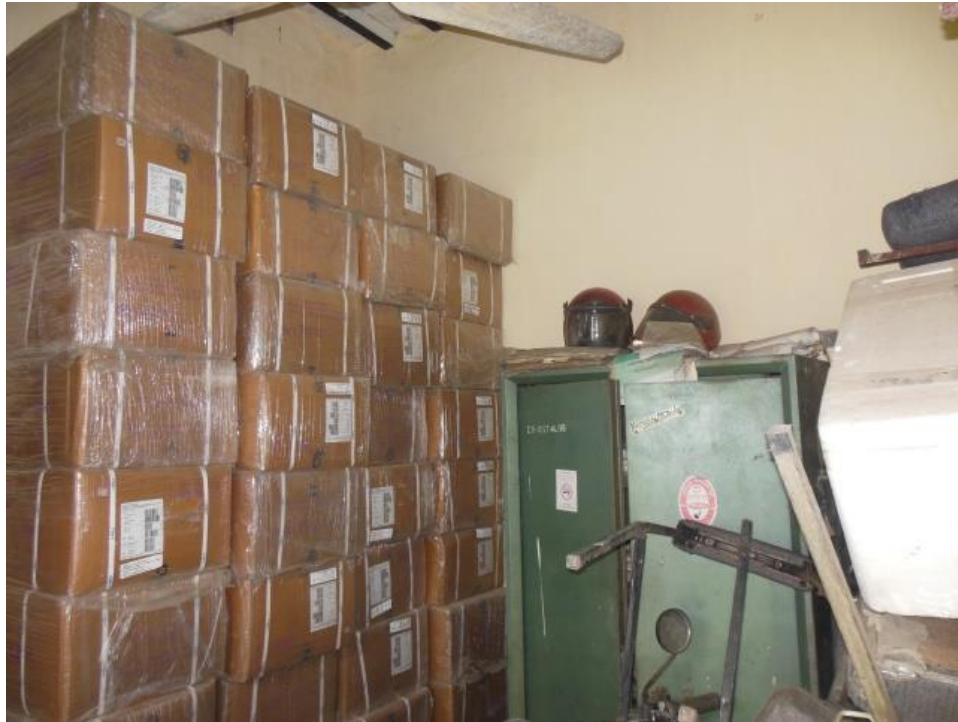
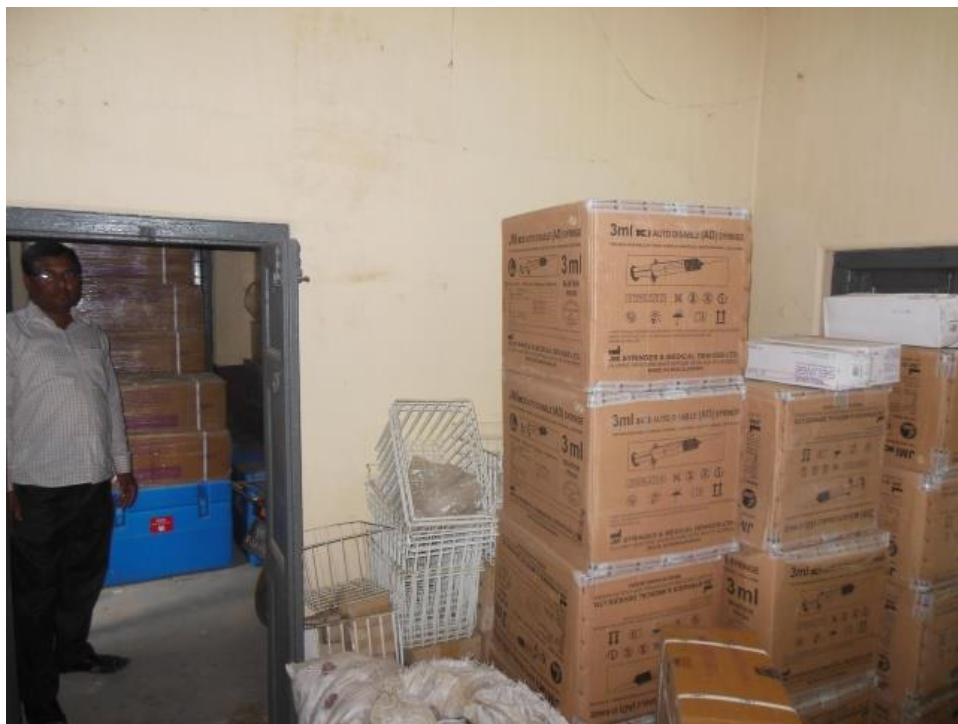
Figure 6.8: Existing Dry Storage Condition (ground floor)

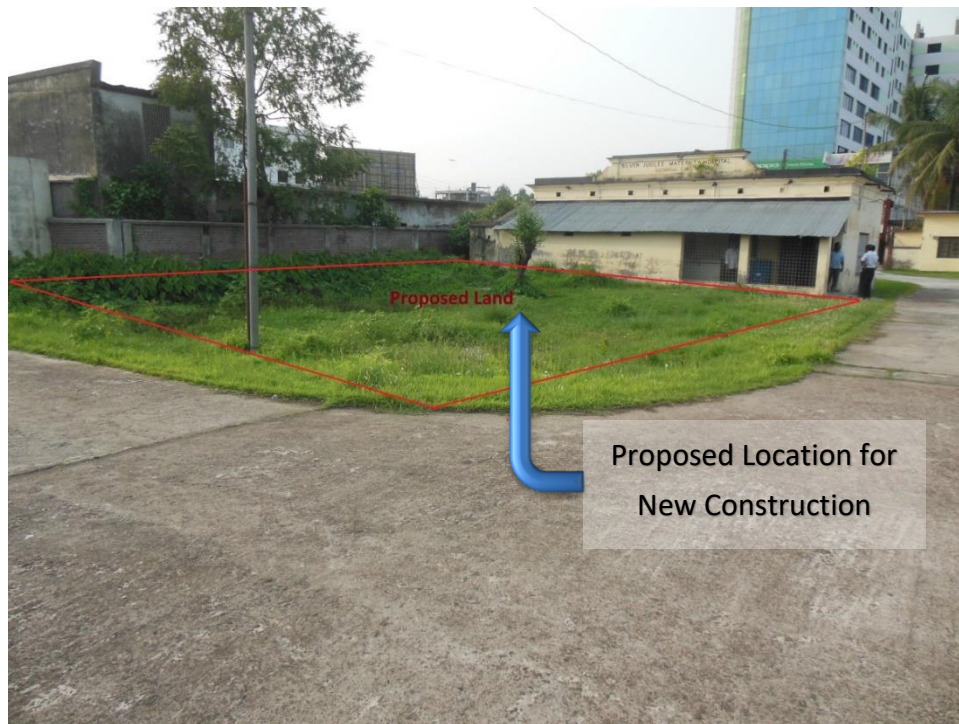
- The land is a marshy land, avg. 1.5 ft. down from road level. So additional sand filling (Approx. 4500 Cft.) will be needed to develop the land.

Figure 8.1: Proposed land for EPI Construction

- An electric pole 5.2ft inside from the road is located inside the proposed land. It can be replaced if full area is required.
- Need to clean the bust and grass from the proposed land before commencement of work.
