**GLOBAL ALLIANCE FOR VACCINES AND IMMUNIZATION (GAVI)
HEALTH SYSTEM STRENGTHENING II (HSS-2) PROGRAMME**

***PRILIMINARY ASSESSMENT REPORT
EPI BUILDING, MOULVIBAZAR***

May 12, 2018

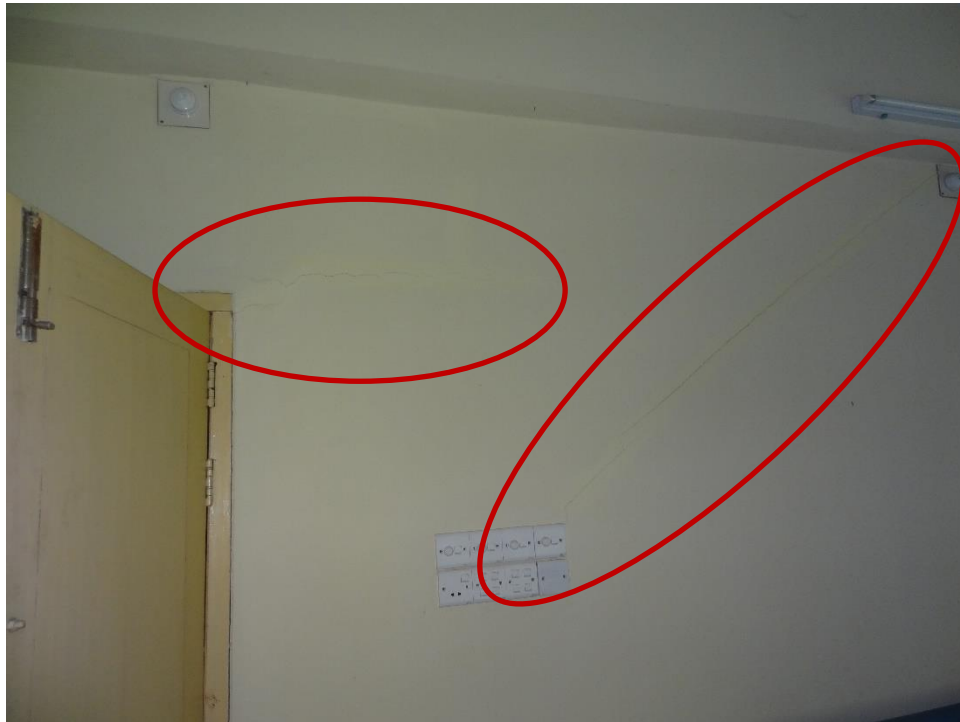
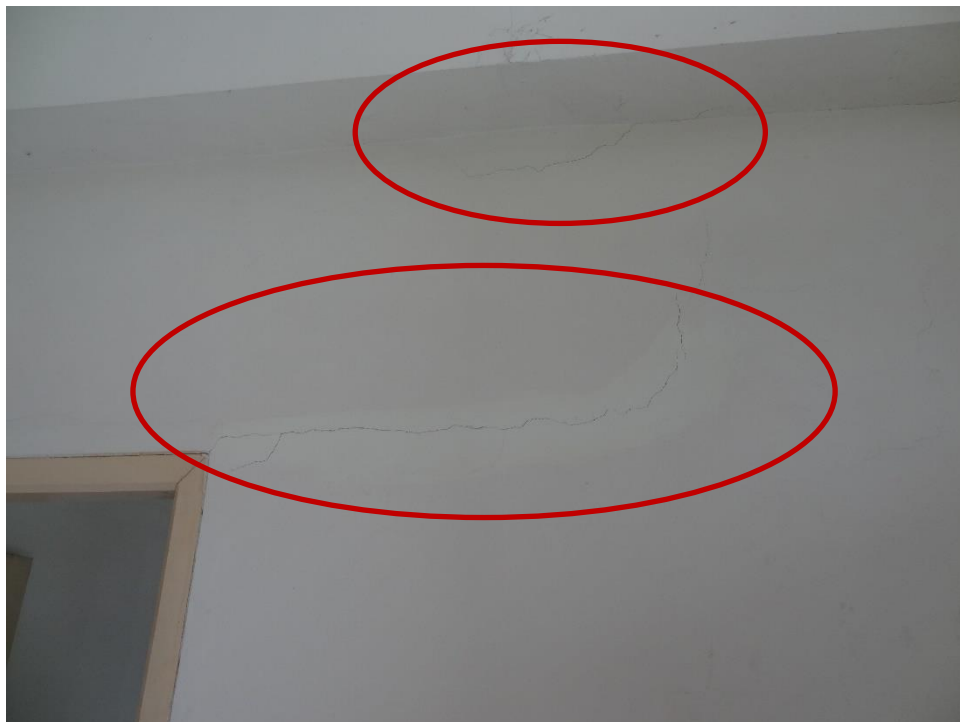
Figure 6.1: Cracked Partition Wall Plaster

- Re-plastering is recommended for walls with minor cracks on plaster.
- Repaint of the existing outer side as well as inner part is recommended.
- To avoid corrosion; red oxide and enamel paint must be applied to the exposed reinforcement.

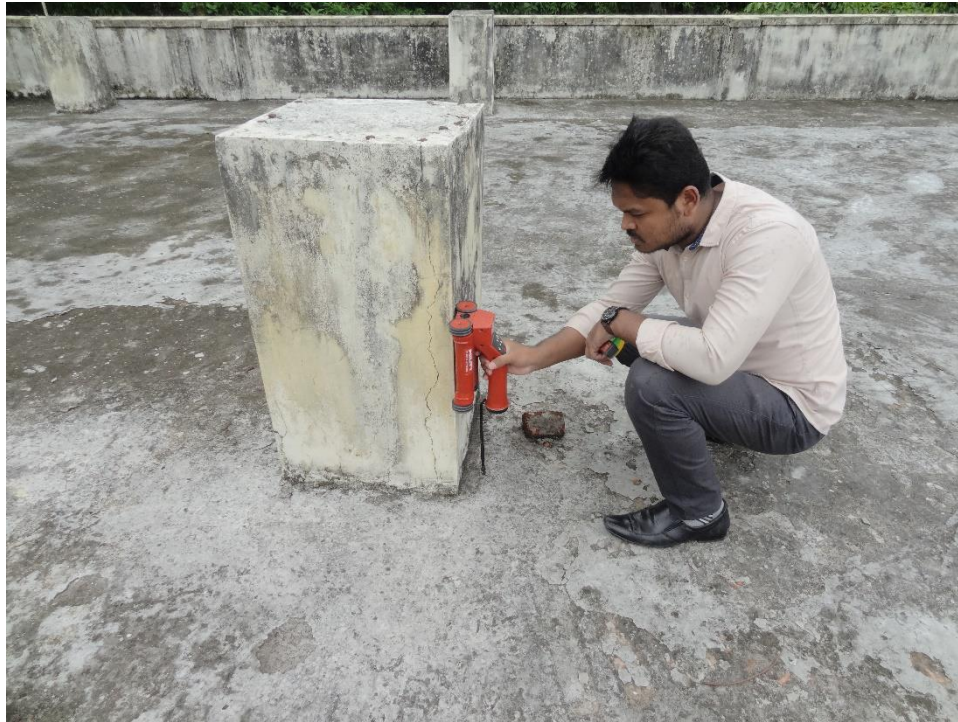
Figure 6.2: Checking of Column Reinforcement and Stirrup Spacing

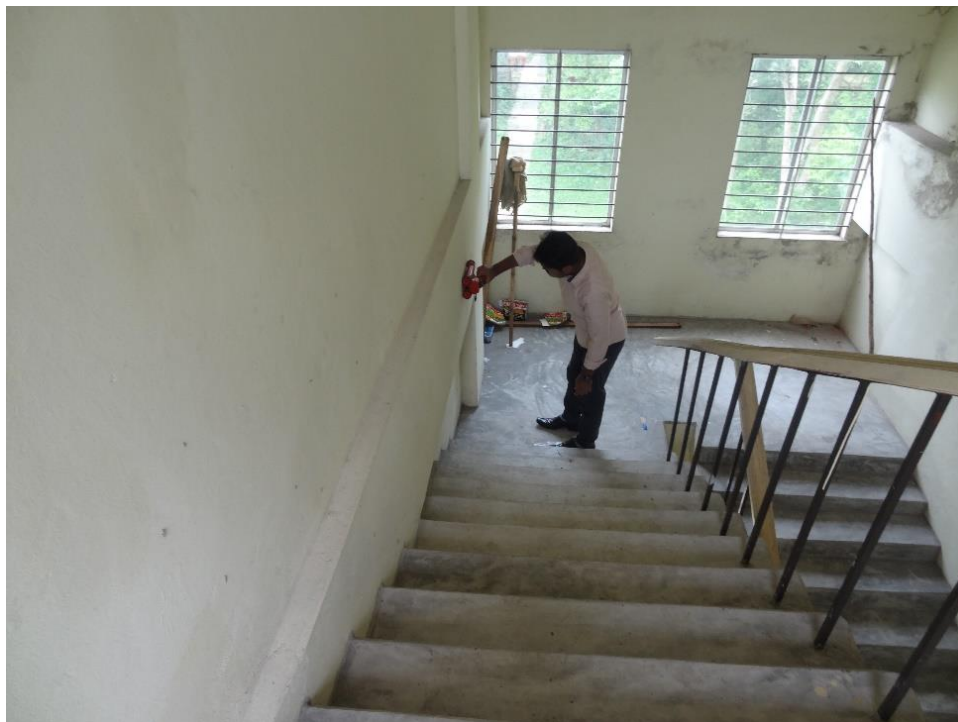
Figure 6.3: Checking of Beam Reinforcement and Stirrup Spacing

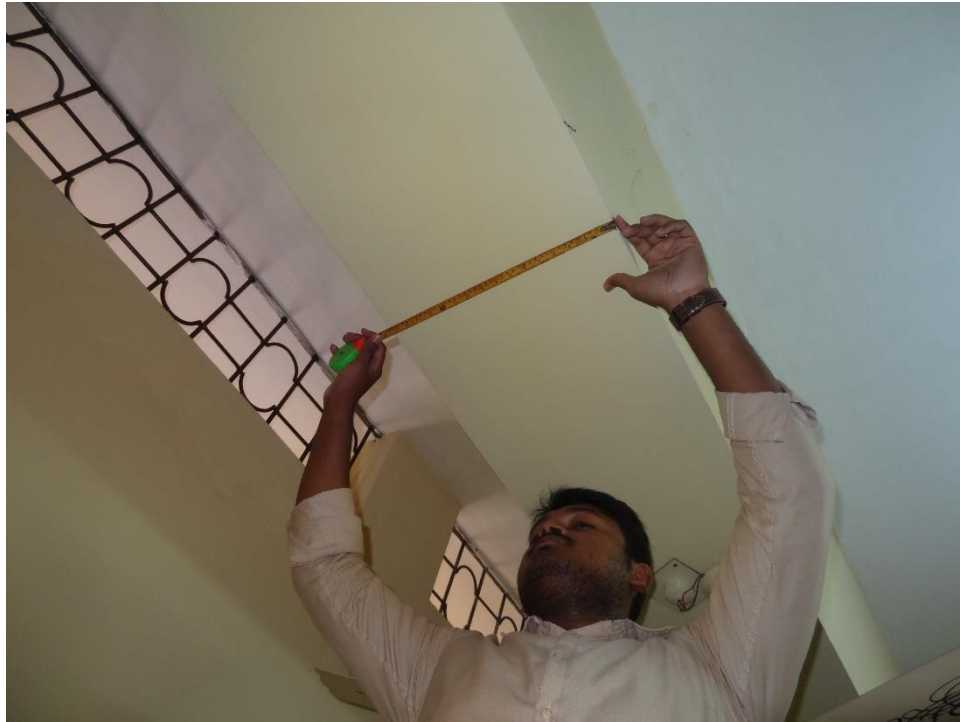
Figure 6.4: Measuring Beam Dimension

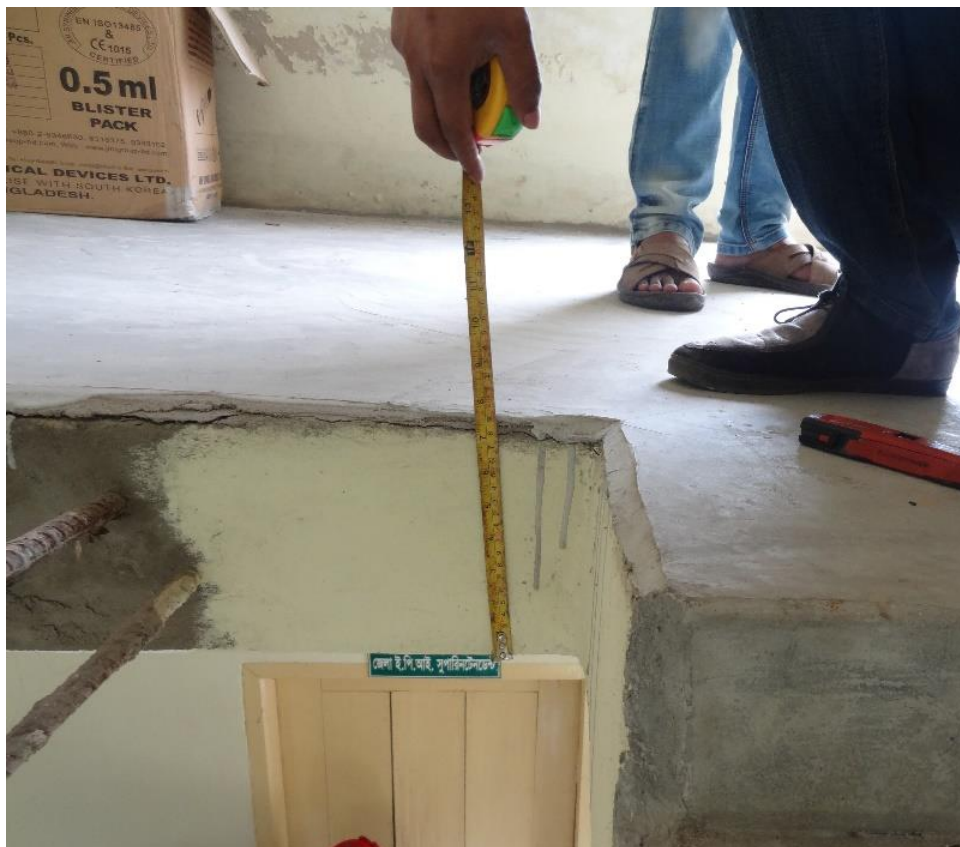
Figure 6.5: Measuring Waist Slab Thickness

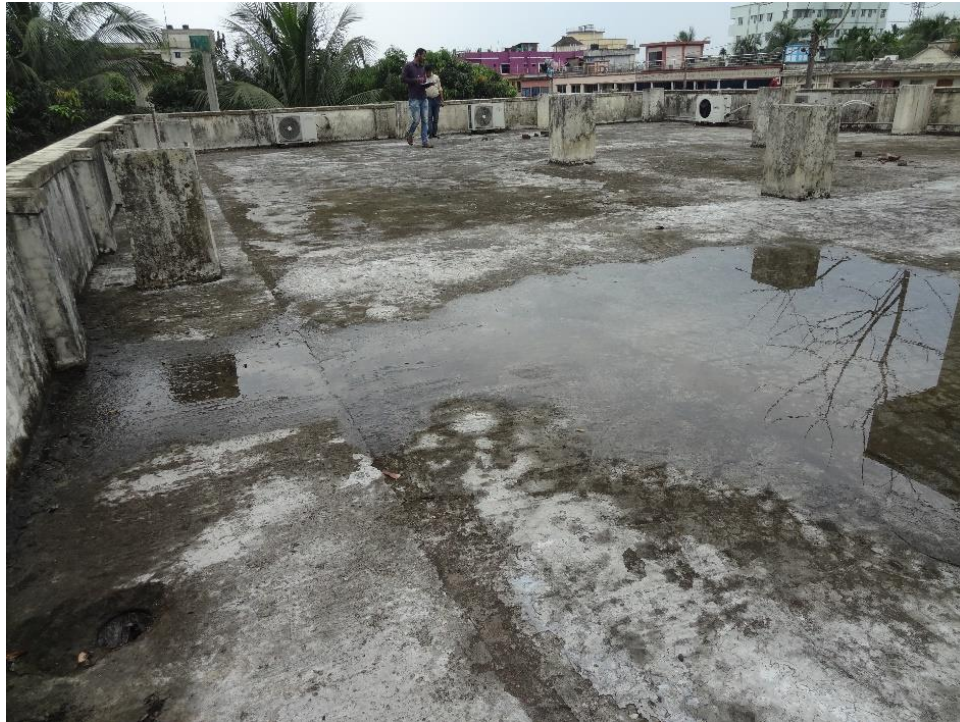
Figure 6.6: Existing Condition of Roof Slab

- Appropriate damp proofing measure should be taken in the affected area.
- Resurfacing is highly recommended for water logged area on the roof surface, because some spalling is found on the roof.

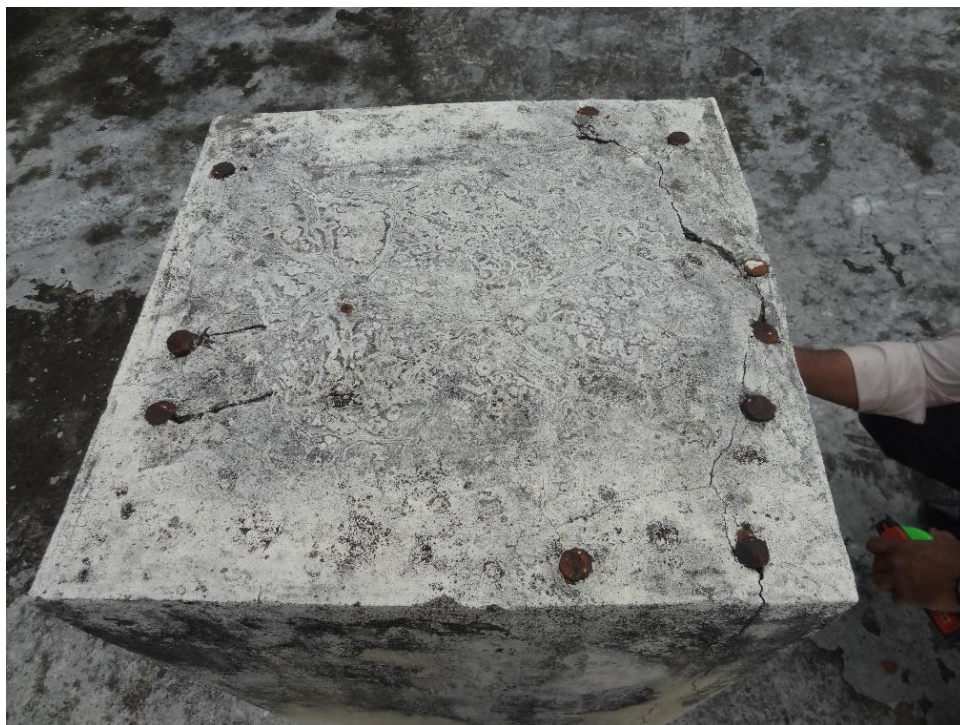
Figure 6.7: Exposed Rebar of Roof False Column

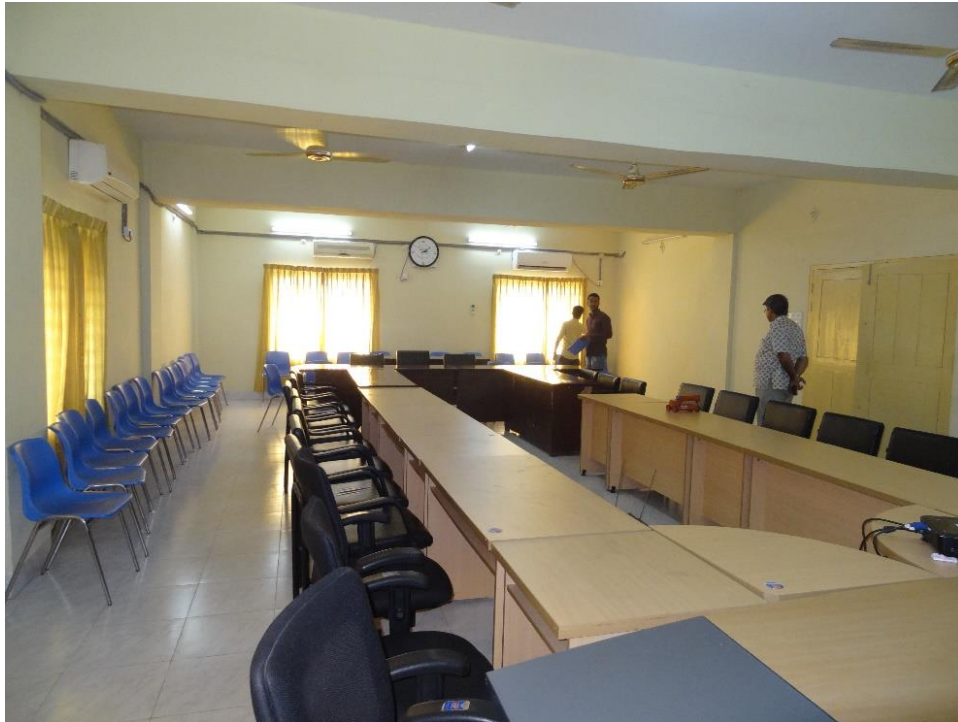
Figure 6.8: Existing Condition of Conference Room at 1st Floor

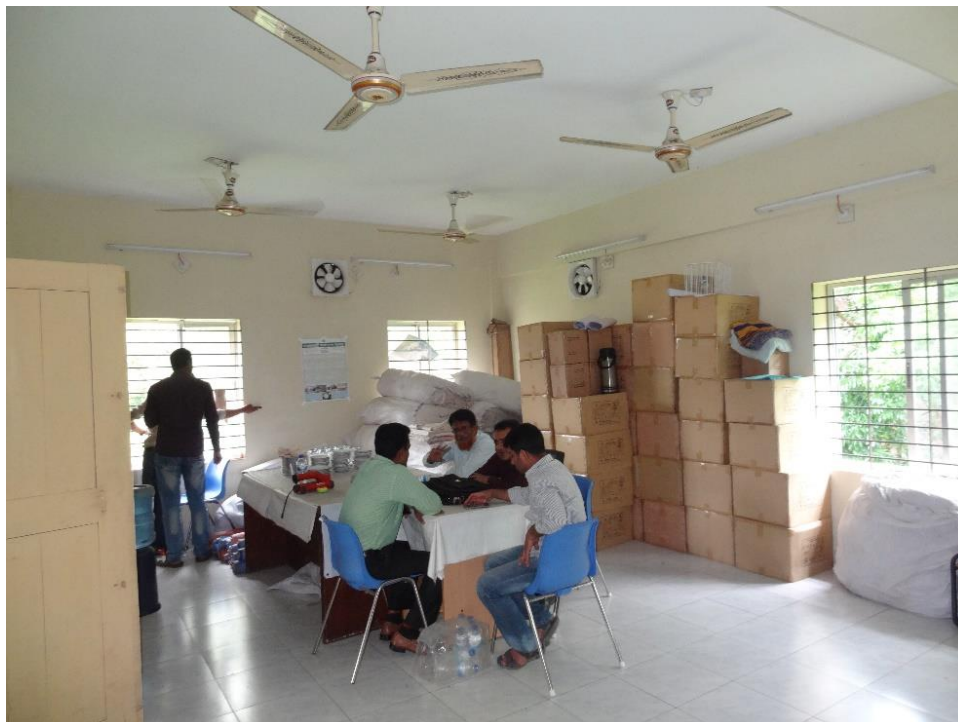
Figure 6.9: Existing Condition of Logistic Room at 1st floor

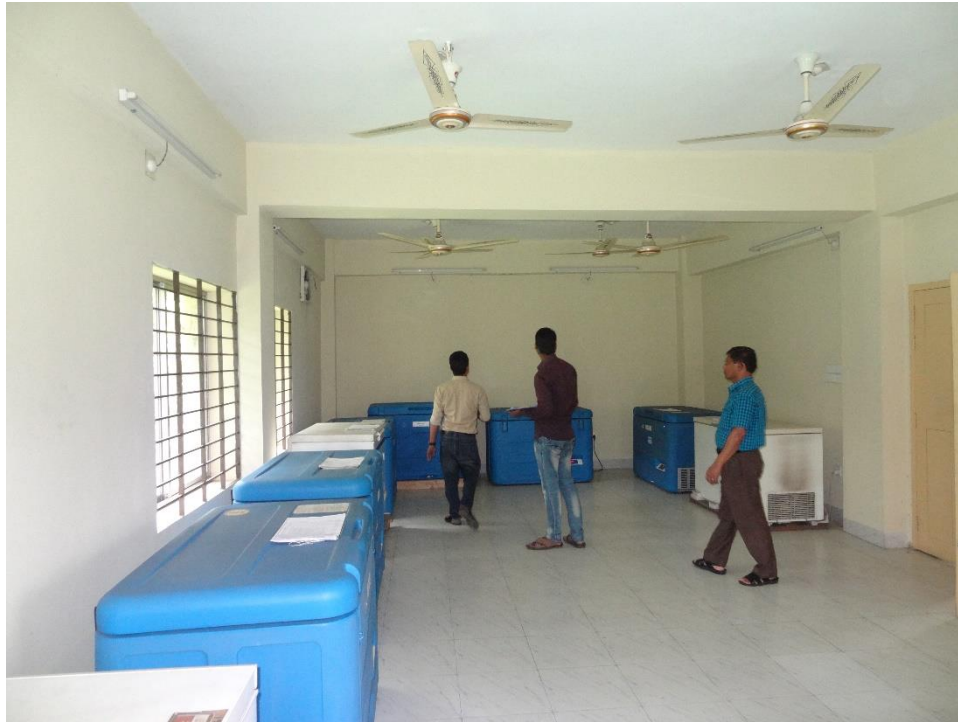
Figure 6.10: Existing Condition of Cold Room at Ground floor

- As per provided guideline of UNICEF, in order to accommodate 1 nos. of WIC, 1 nos. of Freezer and dry store room, the EPI cold room must be renovated.

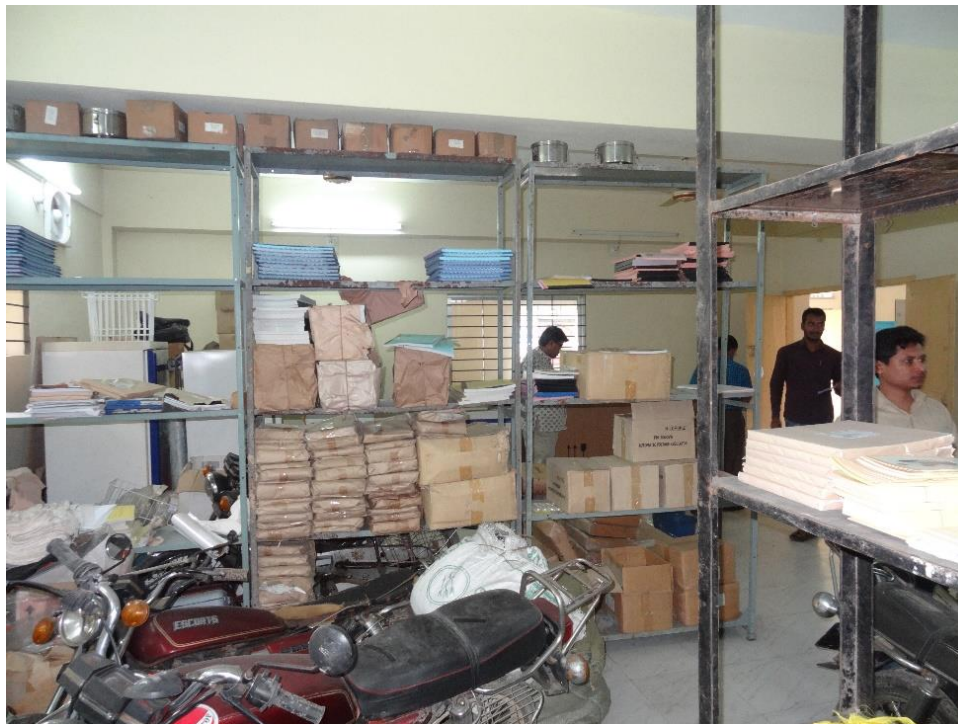
Figure 6.11: Existing Condition of Dry Storage Room at Ground Floor

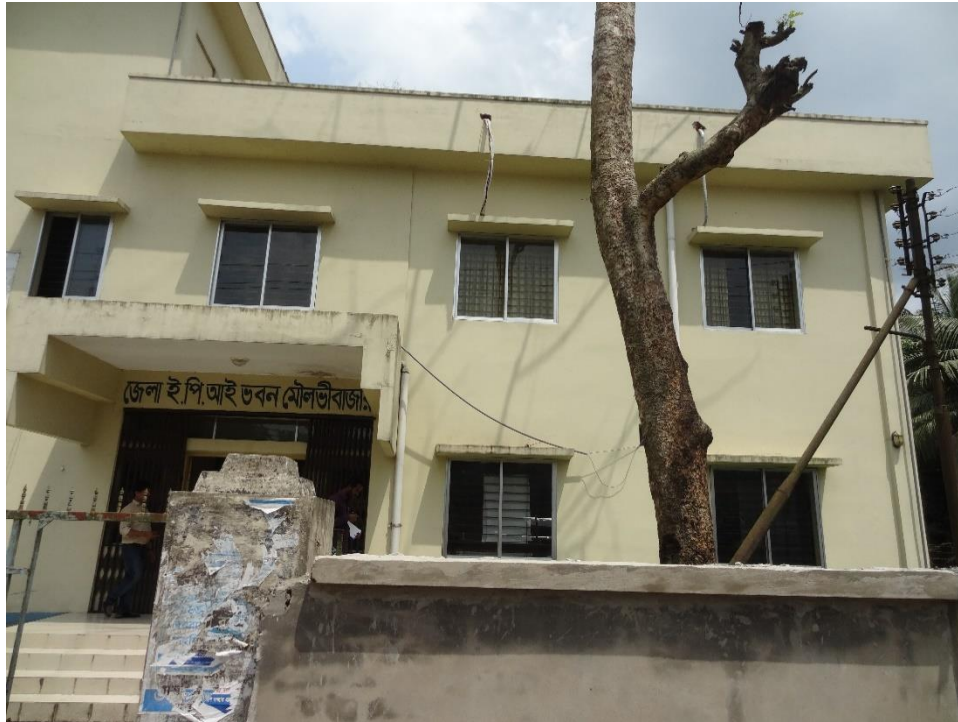
Figure 6.12: Front side Building Condition

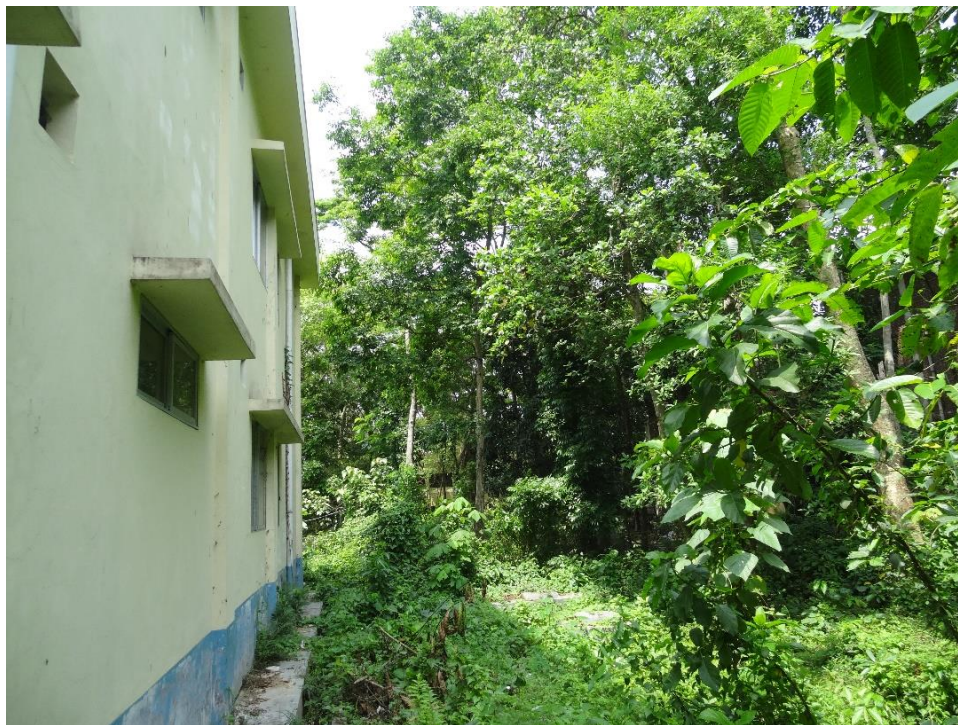
Figure 6.13: Backside Building Condition

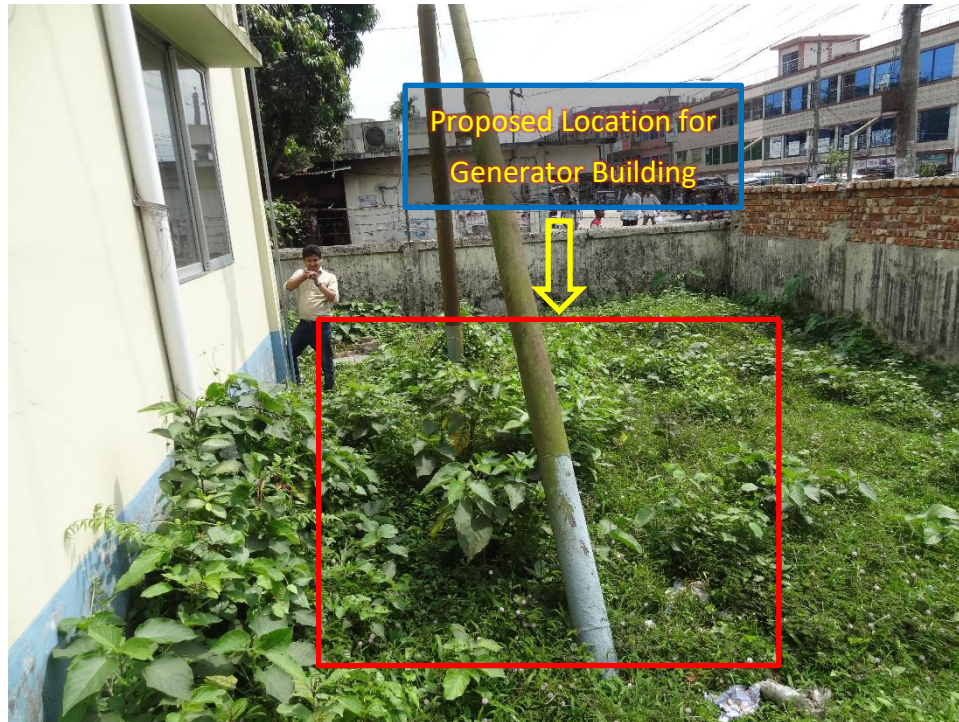
Figure 8.1: Proposed land for the construction of new generator building

- A piece of land is required for the construction of new generator building. In the south-west corner of the front side of the EPI building, land is available to construct a new generator building. We chose this land for generator building and discussed with acting Civil Surgeon about whether we can use this land or not as a generator building. And he confirmed us that they have no problem from the CS office about using this land for a new generator building which will supply uninterrupted electricity to the WIC room.

- For Physical implementation of new generator building, an electric pole need to be shifted from the proposed site, a dead tree need to be cut off and some vegetation needed to get removed. CS sir ensured us he will help us about site clearing issue.
