**GLOBAL ALLIANCE FOR VACCINES AND IMMUNIZATION (GAVI)  
HEALTH SYSTEM STRENGTHENING II (HSS-2) PROGRAMME**

***PRILIMINARY ASSESSMENT REPORT  
EPI BUILDING, NILPHAMARI***

May 12, 2018

**Environment & Infrastructure Management Solution (EIMS) Limited**

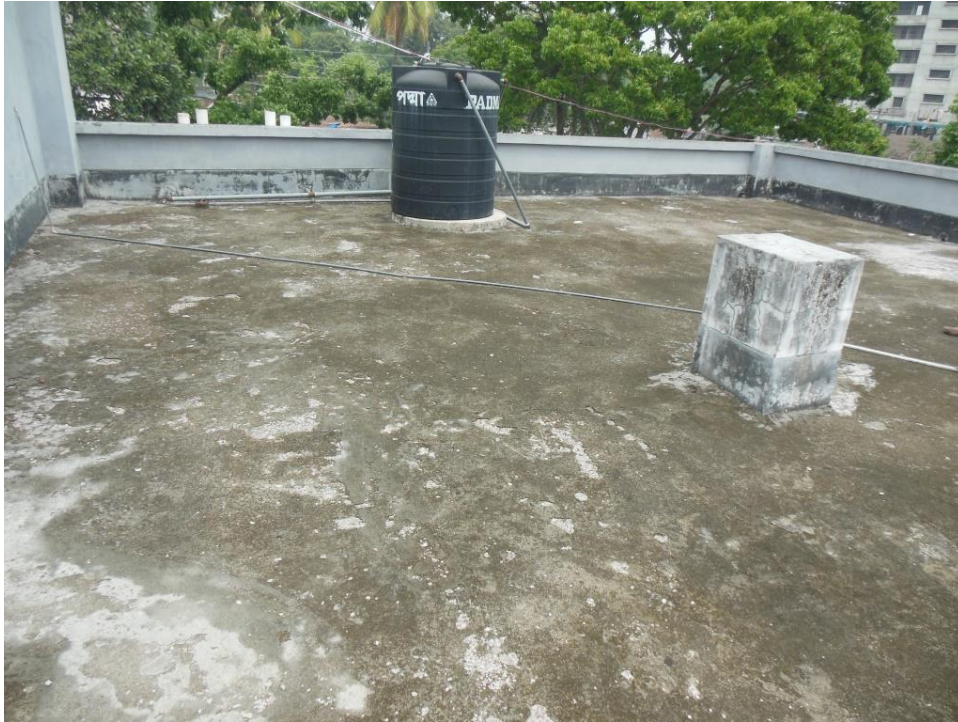
Figure 6.1: Trace of Water Logging and Roof Dampness

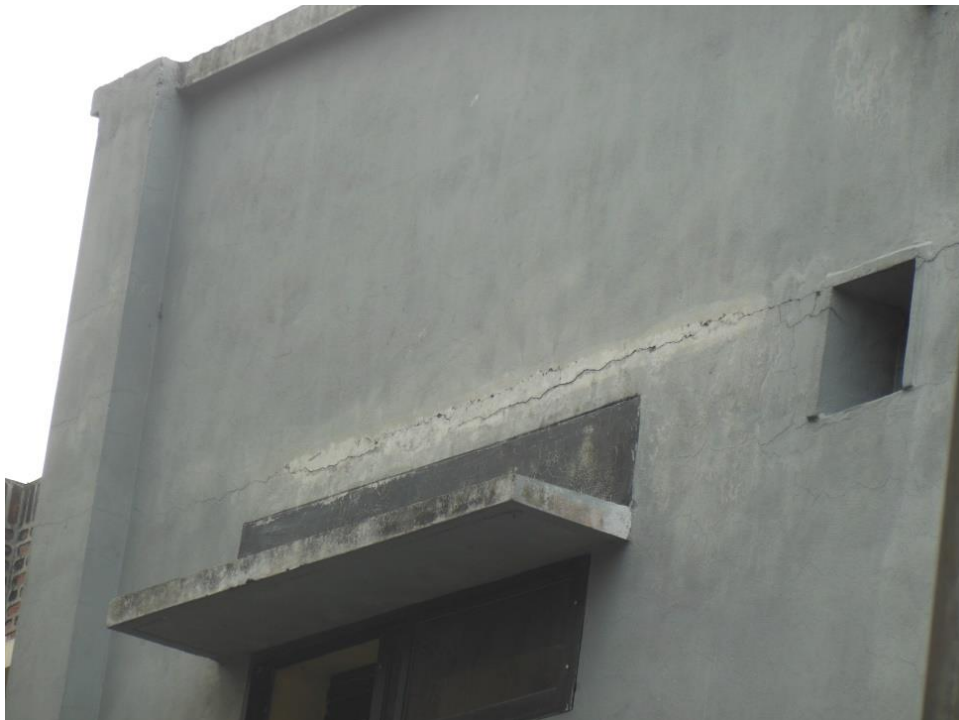
Figure 6.2: Minor Cracks Found On the Exterior Partition Wall

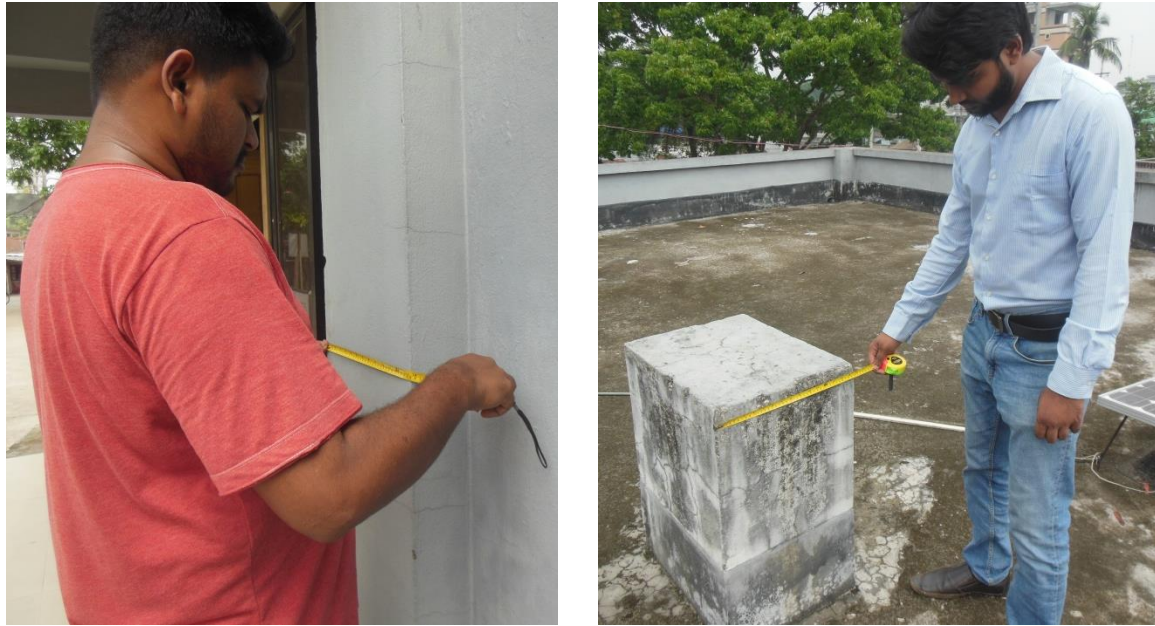
Figure 6.3: Measuring of physical dimension of column

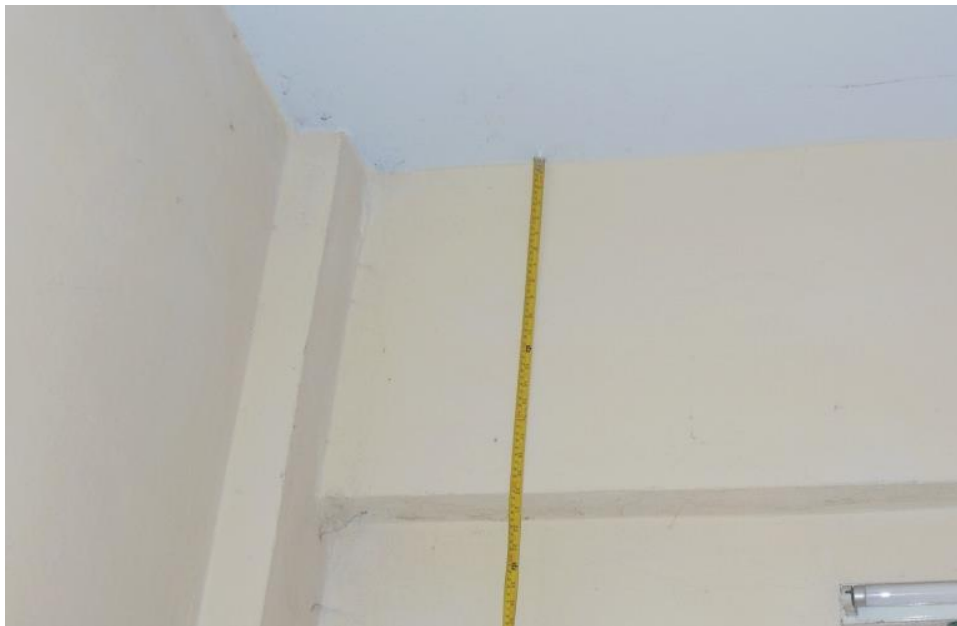
Figure 6.4: Measuring of physical dimension of beam

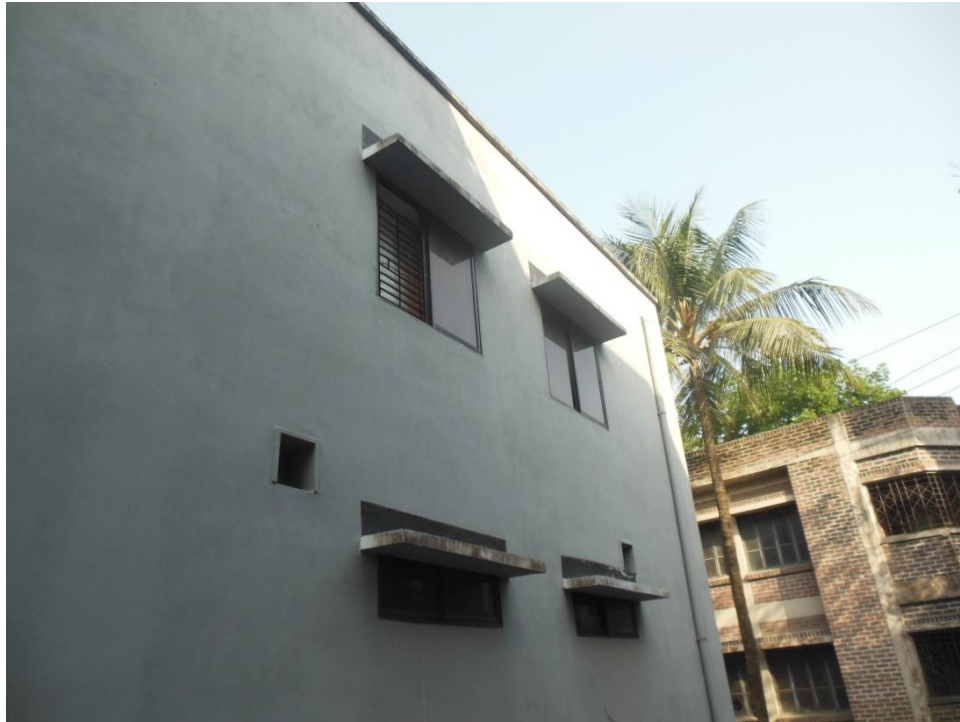
Figure 6.5: Backside condition of building

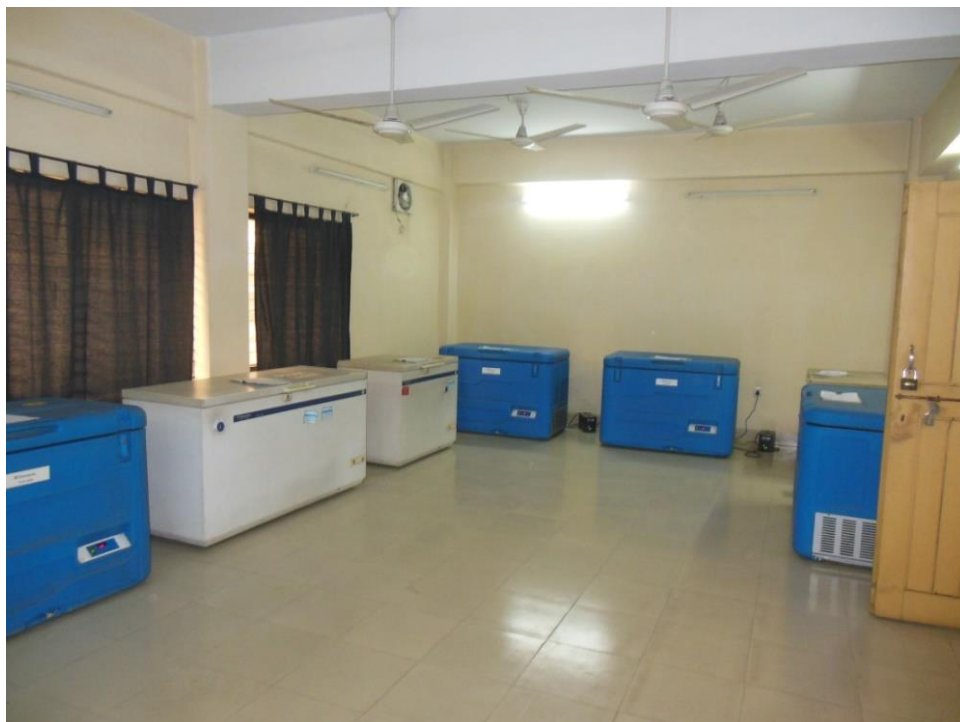
Figure 6.6: Existing Vaccine Storage Room Condition (ground floor)

- As per provided guideline of UNICEF, in order to accommodate 2 nos. of WIC, 2 nos. of Freezer and dry store room, the EPI cold room must be renovated.

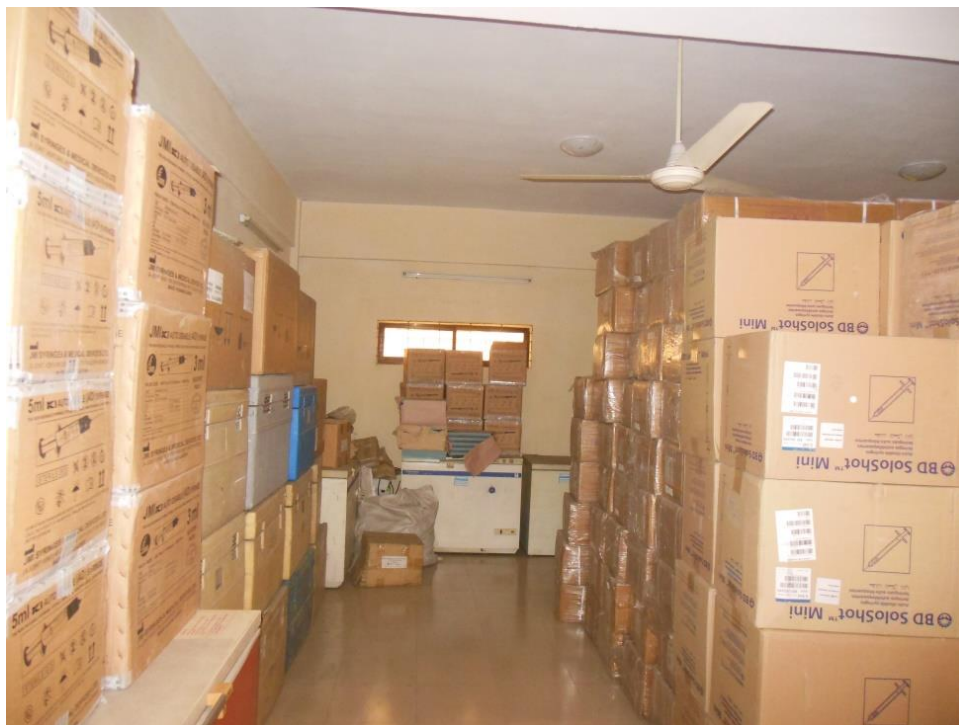
Figure 6.7: Existing Dry Storage Condition (ground floor)

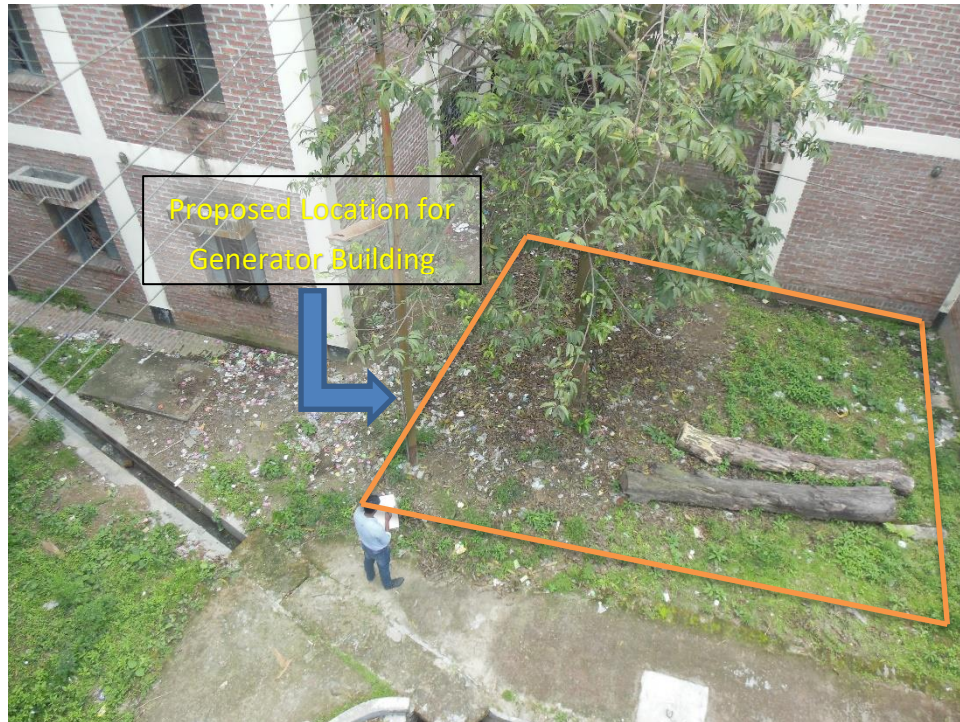
Figure 8.1: Proposed land for the construction of new generator building

- A piece of land is required for the construction of new generator room. During assessment work Civil Surgeon was not present. Generator space is ensured by Chief Officer of Upazila Health and Family planning Office. He proposed a place for generator building behind the existing EPI Building which will supply uninterrupted electricity to the WIC room.
- The land is slightly low from the road level. Need additional filling for land development purpose.

- This land is occupied by Nursing Institute now. Need to confirm the ownership before commencement of work from the Civil Surgeon Office.
- A small tree needs to get cut down for cleaning the land.
- An electric pole is located inside the land. It needs to move away if the foundation of generator will be interrupted by Nursing Institute Building Foundation.
