**GLOBAL ALLIANCE FOR VACCINES AND IMMUNIZATION (GAVI)
HEALTH SYSTEM STRENGTHENING II (HSS-2) PROGRAMME**

***PRILIMINARY ASSESSMENT REPORT
EPI BUILDING, RANGAMATI***

May 12, 2018

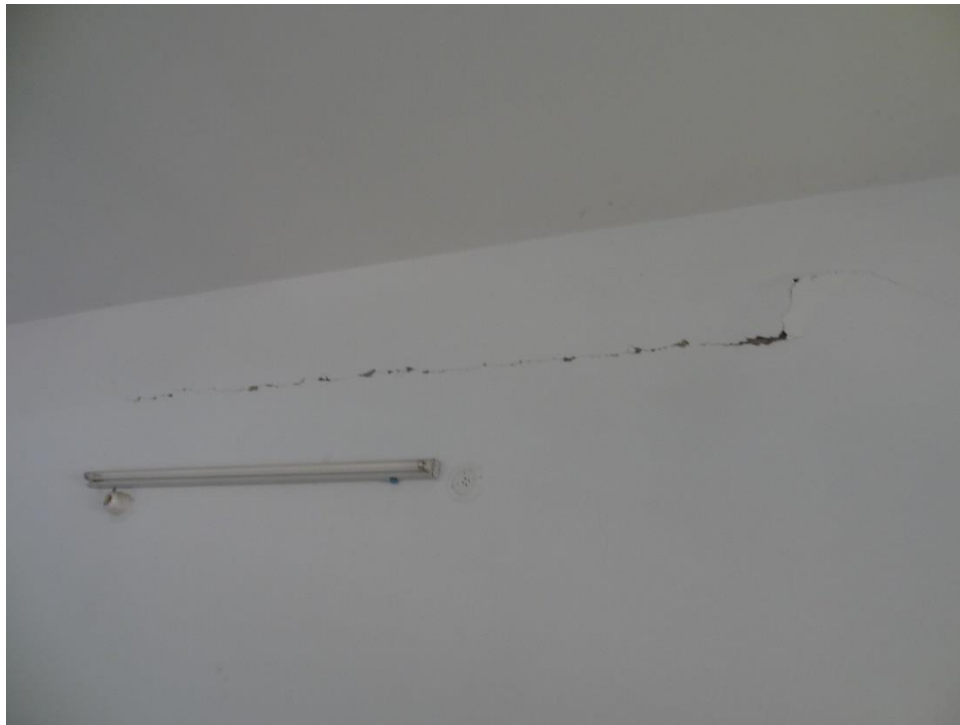
Figure 6.1: Cracked Plaster in between beam & wall joint

- Re-plastering is recommended for walls with minor cracks on plaster.
- Repaint of the existing outer side as well as inner part is recommended.
- To avoid corrosion; red oxide and enamel paint must be applied to the exposed reinforcement.

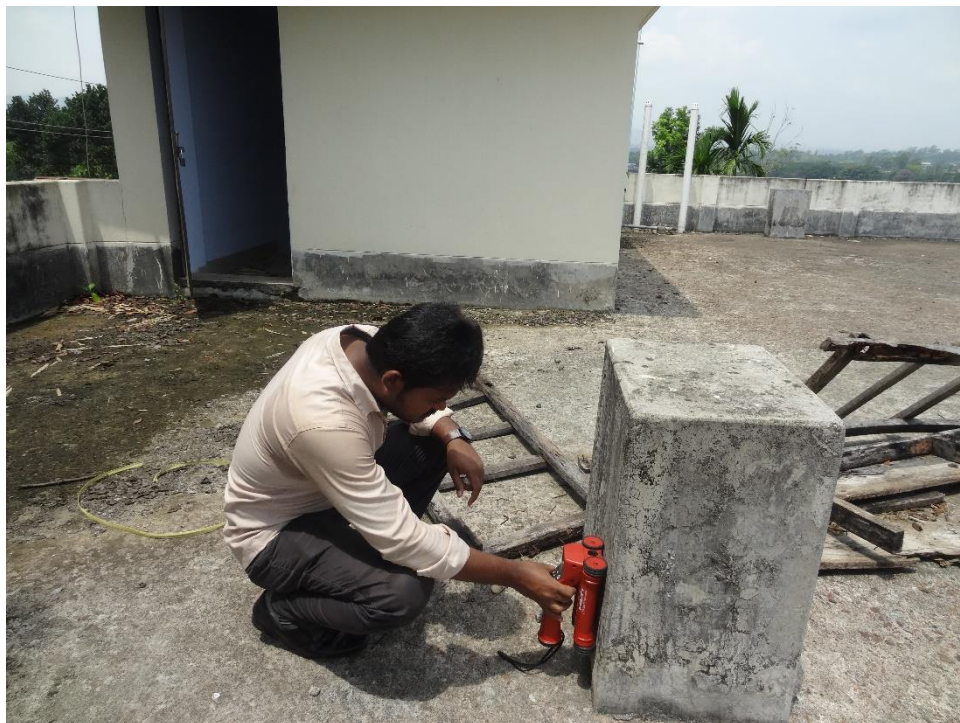
Figure 6.2: Checking the Column Reinforcement

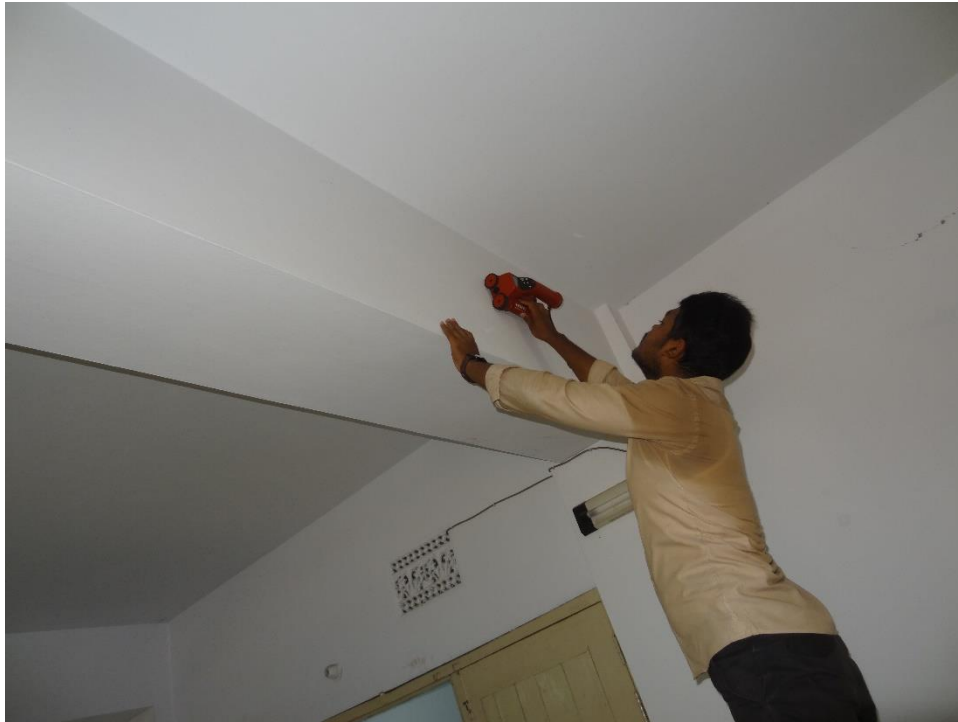
Figure 6.3: Checking of Beam Reinforcement and spacing

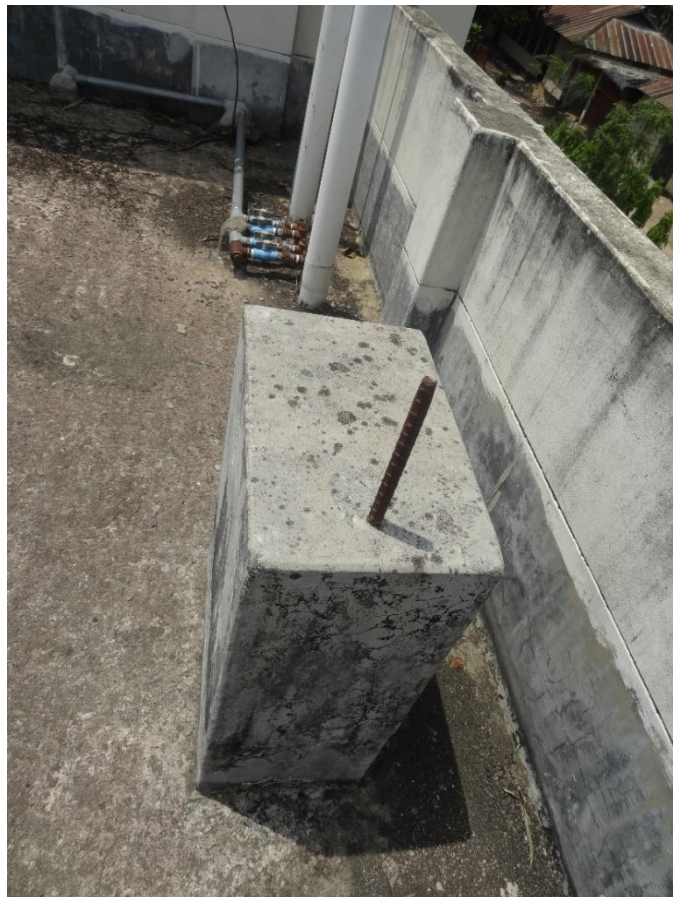
Figure 6.4: Exposed Rebar of Roof False Column

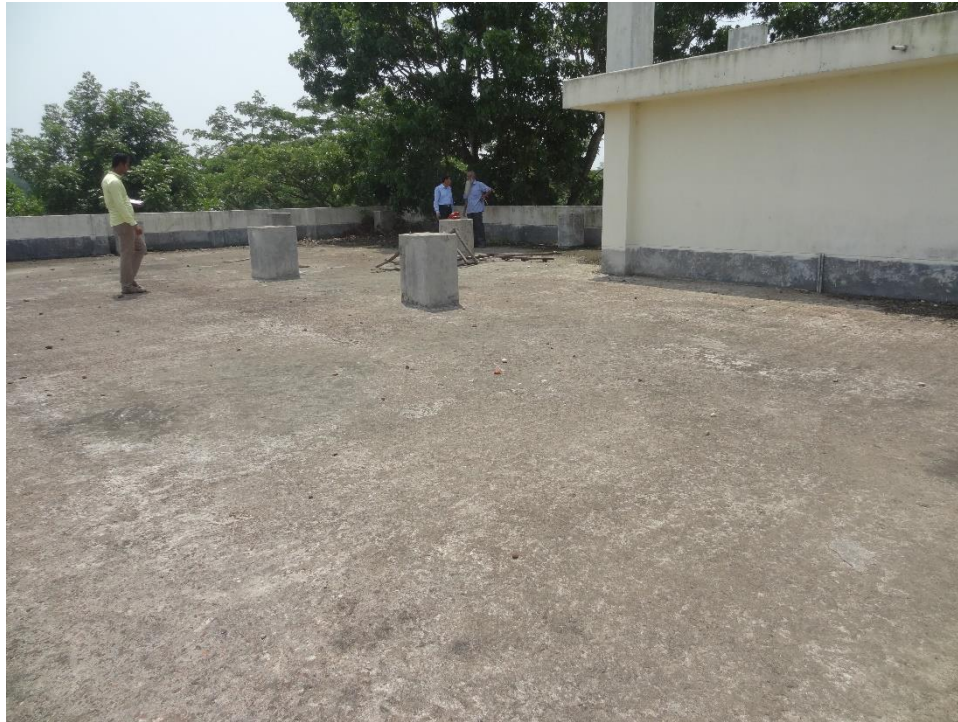
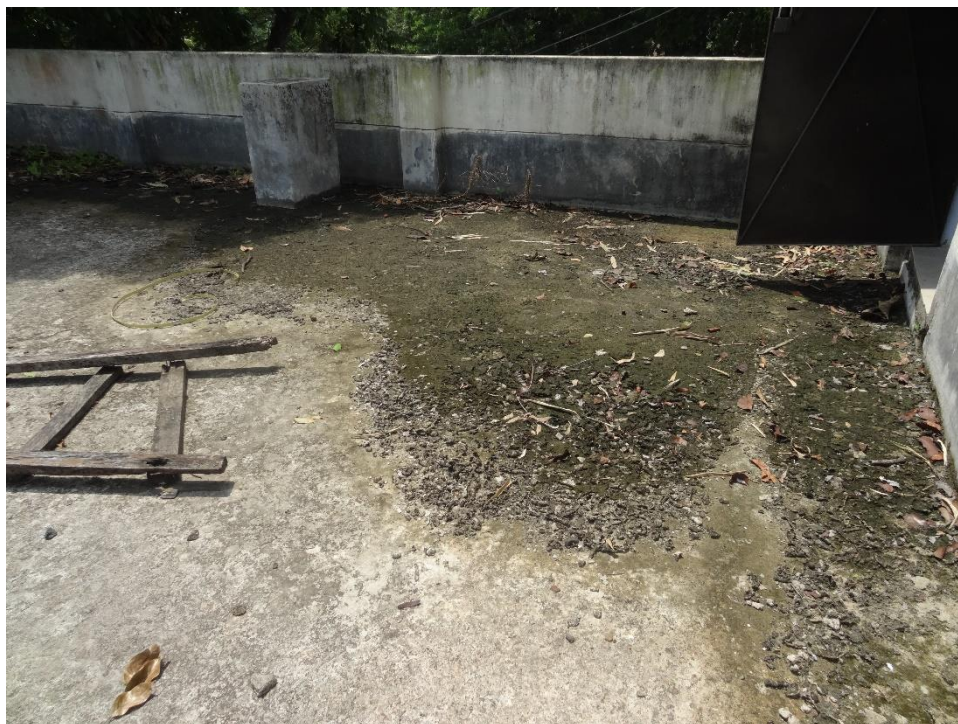
Figure 6.5: Existing Condition of Roof Slab

- Appropriate damp proofing measure should be taken in the affected area.
- Resurfacing is highly recommended for water logged area on the roof surface, because some spalling is found on the roof and the roof surface isn't properly sloped.

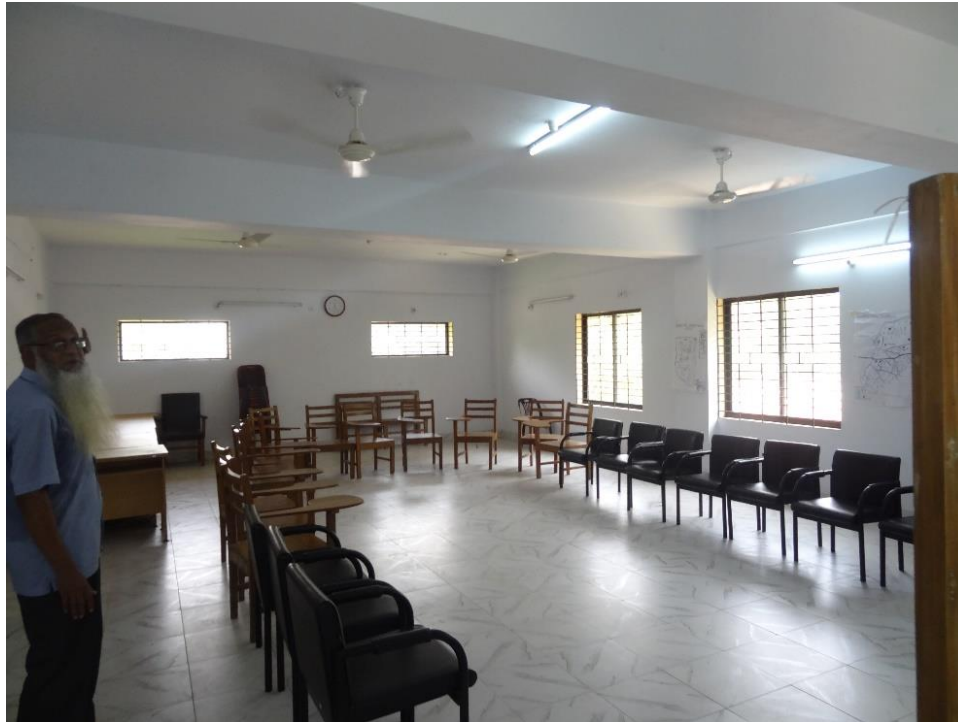
Figure 6.6: Existing condition of Conference Room at 1st Floor

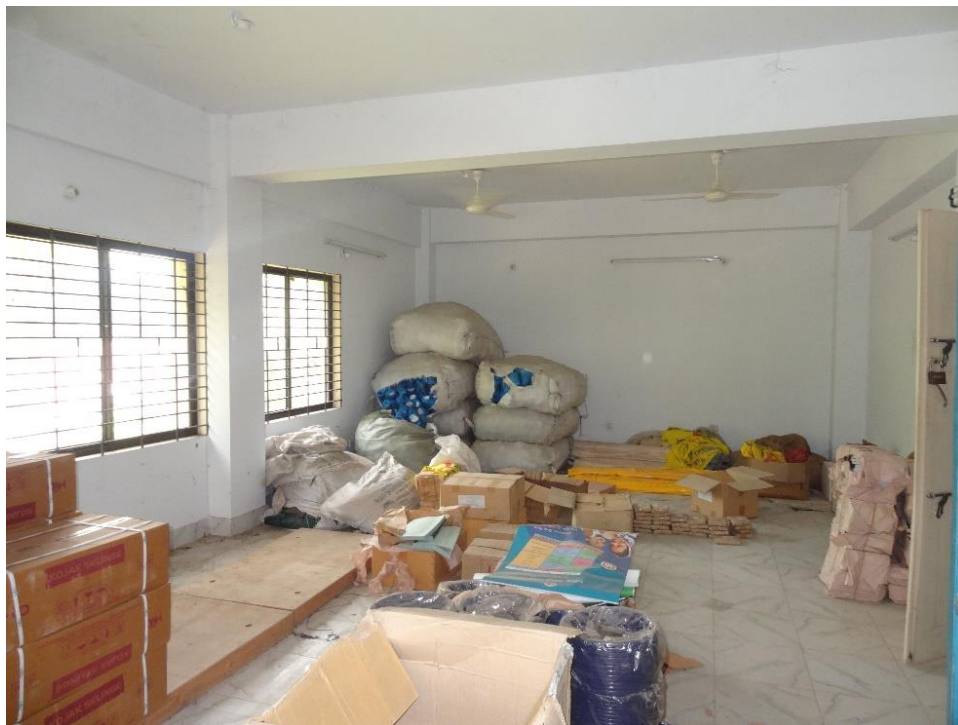
Figure 6.7: Existing Condition of Dry Store at 1st Floor

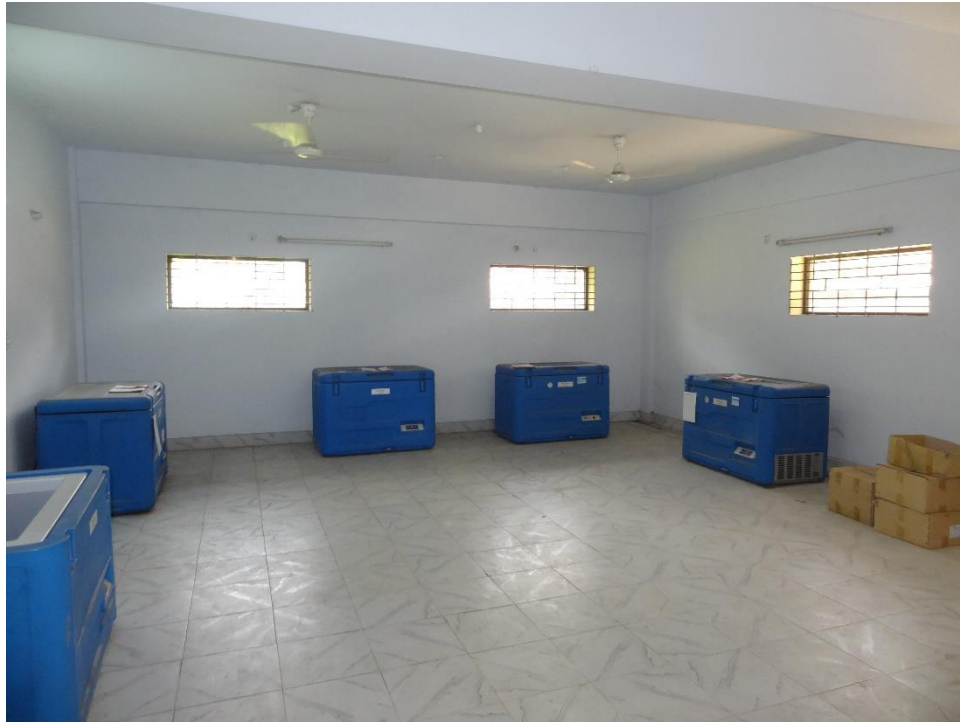
Figure 6.8: Existing condition of Cold Room at Ground floor

- As per provided guideline of UNICEF, in order to accommodate 1 nos. of WIC, 1 nos. of Freezer and dry store room, the EPI cold room must be renovated.

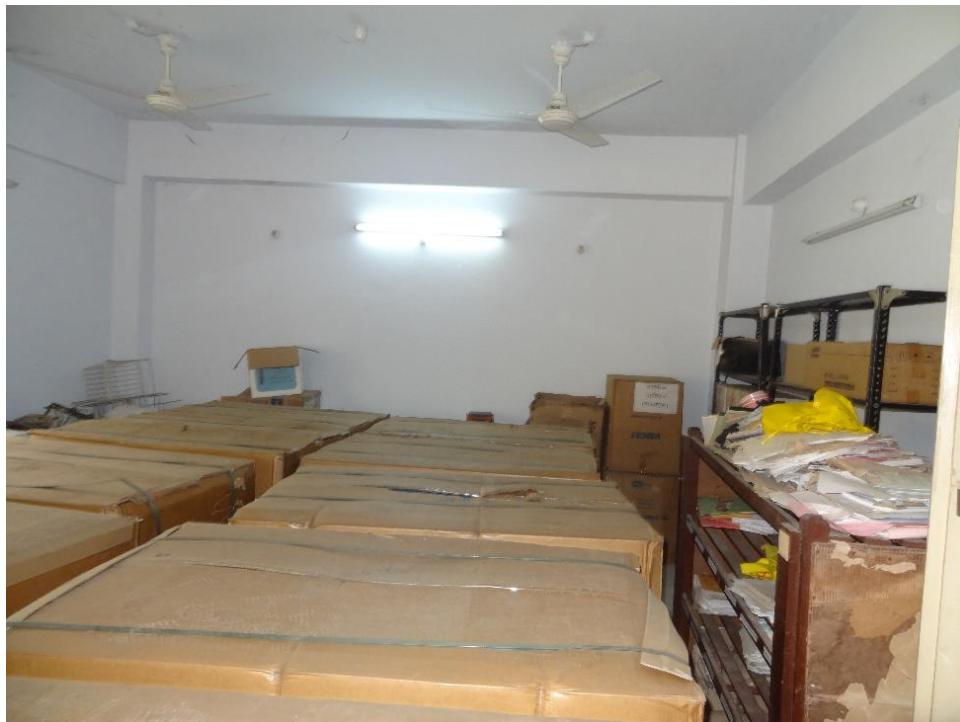
Figure 6.9: Intake ILR in Logistic Room at Ground floor

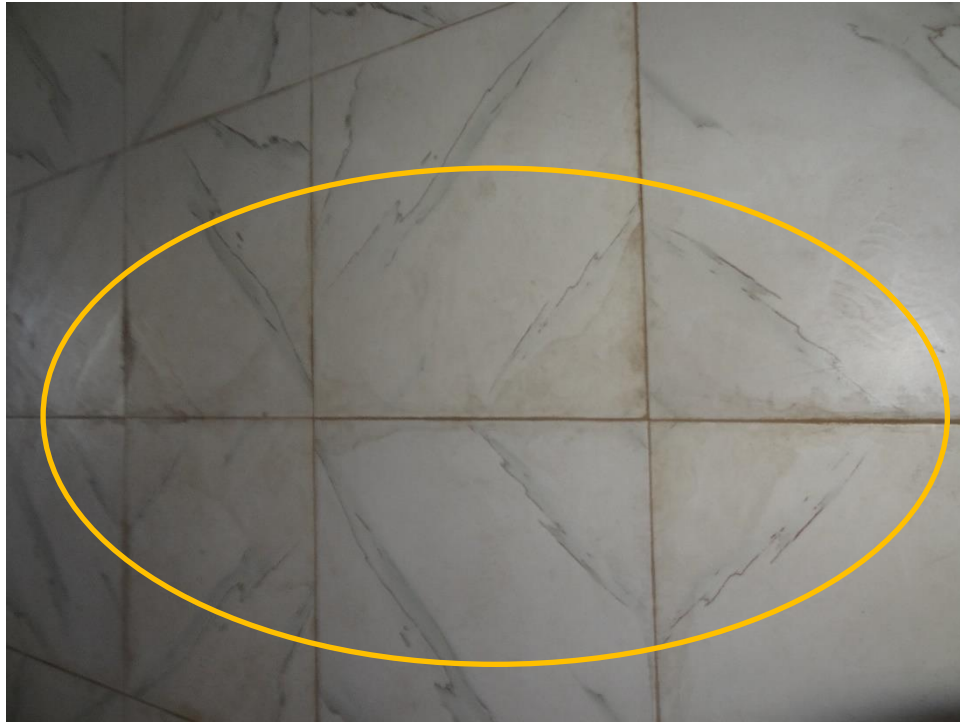
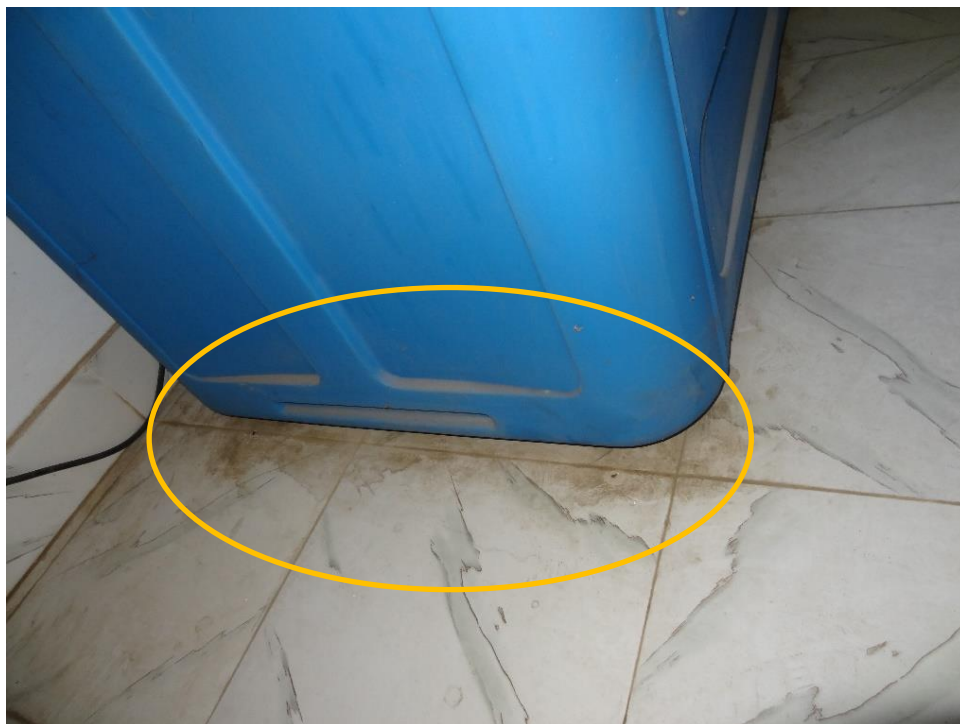
- No major structural distress or cracks was observed in the assessed building. But some minor crack was found in the interior and exterior plaster on the wall which can be enlarged the near future.
- No major Dampness was found in the plastering surface and on the roof slab, but water logging was found in a portion of the roof slab due to uneven roof sloping & dust which can be cause of roof dampness.
- Exposed reinforcement found in the roof false column of the building.
- The factor of safety for three columns (selected as per the tributary area of gravity loading) is found satisfactory. Detail calculation of factor of safety are attached in **Annex-I**.
- No Settlement was found in the building by observing interior wall.
- During rainy season ground floor tiles soaked water from soil and sometimes submerged under water.

Figure 6.10: Sign of past water mark during rainy season at Ground Floor

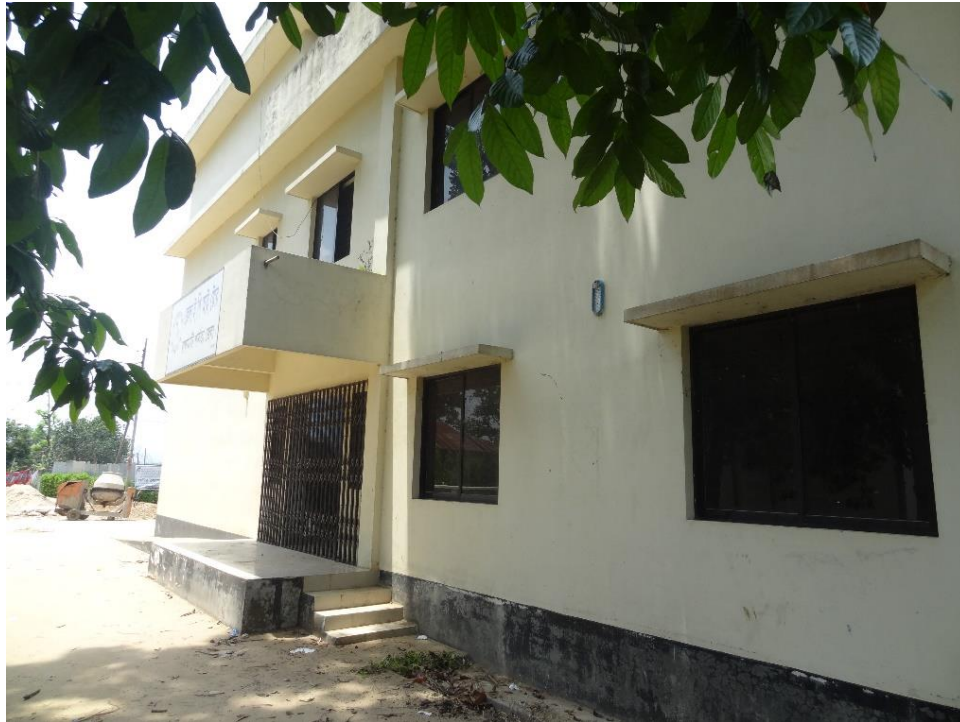
Figure 6.11: Front side Building Condition

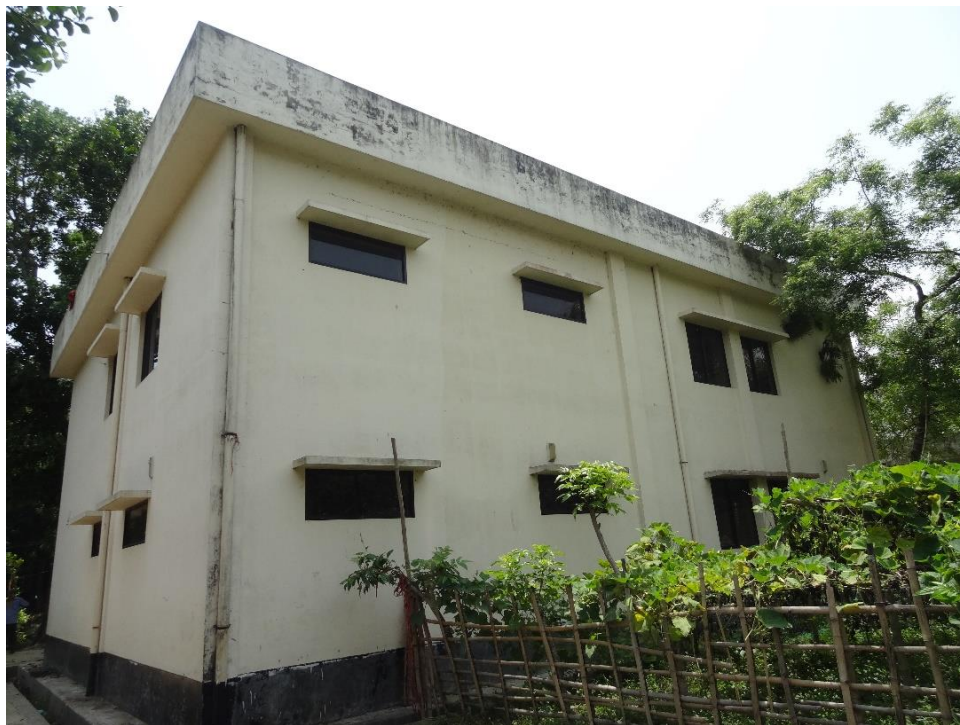
Figure 6.12: Backside Building Condition

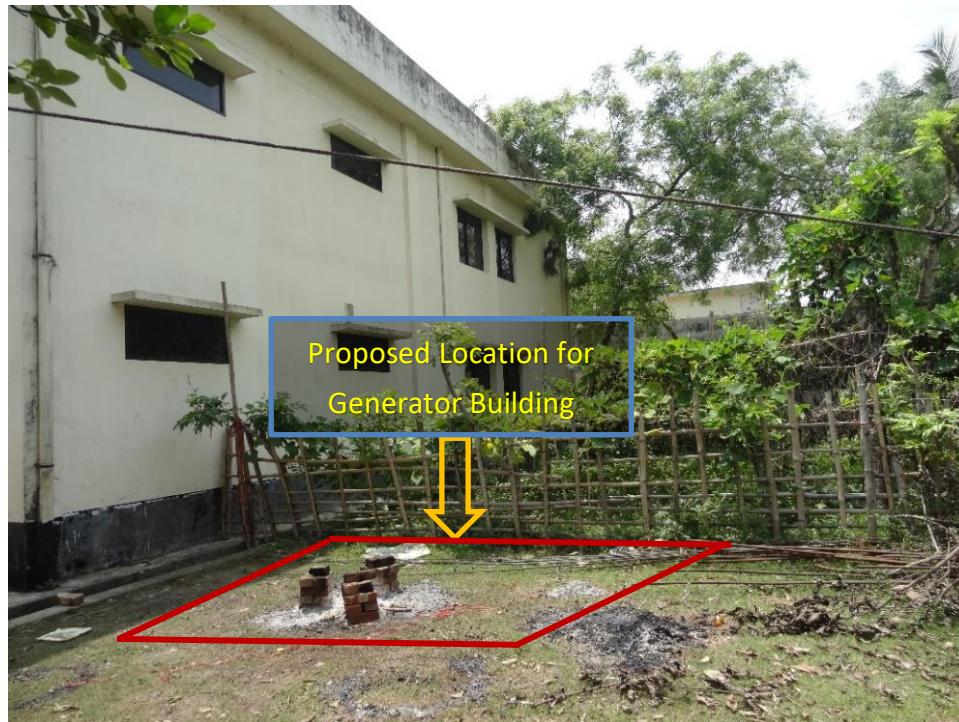
Figure 8.1: Proposed land for new generator building

- A piece of land is required for the construction of new generator room. In the north-east side of EPI building, land is available to construct a new generator room. We chose this land for generator room and discussed with Civil Surgeon representatives about whether we can use this land or not as a generator

- For Physical implementation of new generator building; no problem will be raised because the land is open and no tree or structure is located there, only some vegetation needed to get removed.
